DOE ACCIDENT PREVENTION AND INVESTIGATION

Bi-Annual Summary Report

U.S. Department of Energy ▪ Office of Health, Safety and Security ▪ AI-2013-02 ▪ January 28, 2014

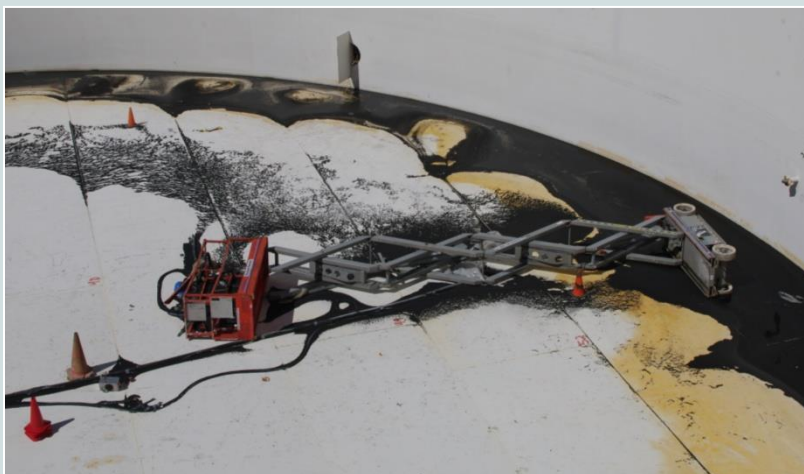
Scissor Lift Accident in the West Hackberry Brine Tank-14 Resulting in Injury, February 7, 2013

The direct cause of the accident was lateral forces exceeded the capability of the scissor lift to remain upright.

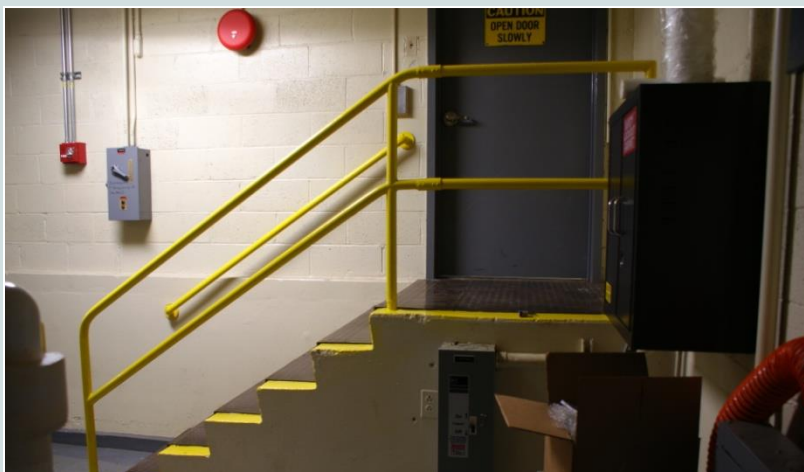
Stairway Fall Resulting in a Federal Employee Fatality at DOE Headquarters, Germantown, Maryland June 1, 2013

The Board identified the direct cause of this accident to be that the FMS fell while descending or transitioning from the stairs to the floor striking his head on the floor of MER 7 resulting in a fatal head injury.

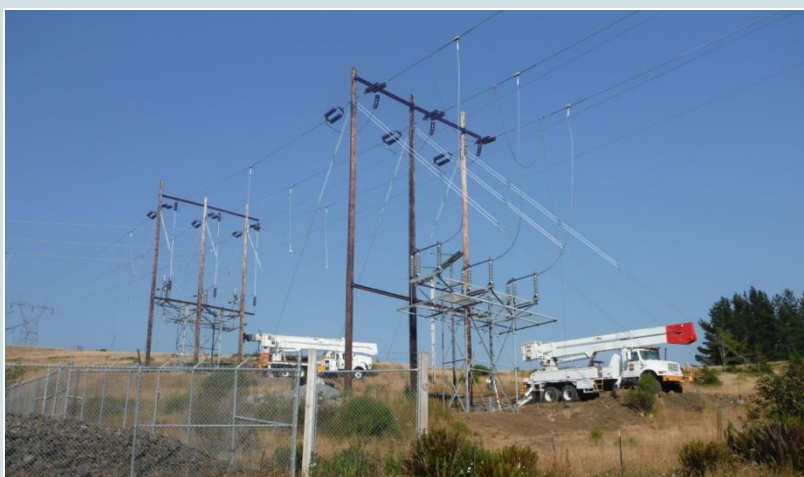
Wilson Construction Company Employee Fatality on the Bandon-Rogue No. 1 115kV Line, July 30, 2013

After examining the evidence and performing analysis of the identified events and causal factors, the Board found that the direct cause of the accident was that Crew Foreman 2 made contact with a difference of potential across the blade end insulator stack of B447.
