# DOE ACCIDENT PREVENTION AND INVESTIGATION

## *Bi-Annual Summary Report*

U.S. Department of Energy ▪ Office of Health, Safety and Security ▪ AI-2013-02 ▪ January 28, 2014

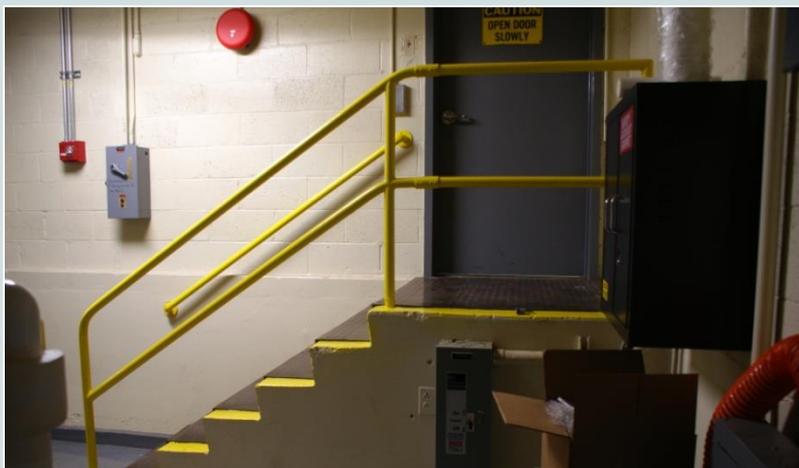
Stairway Fall Resulting in a Federal Employee Fatality at DOE Headquarters, Germantown, Maryland June 1, 2013

The Board identified the direct cause of this accident to be that the FMS fell while descending or transitioning from the stairs to the floor striking his head on the floor of MER 7 resulting in a fatal head injury.

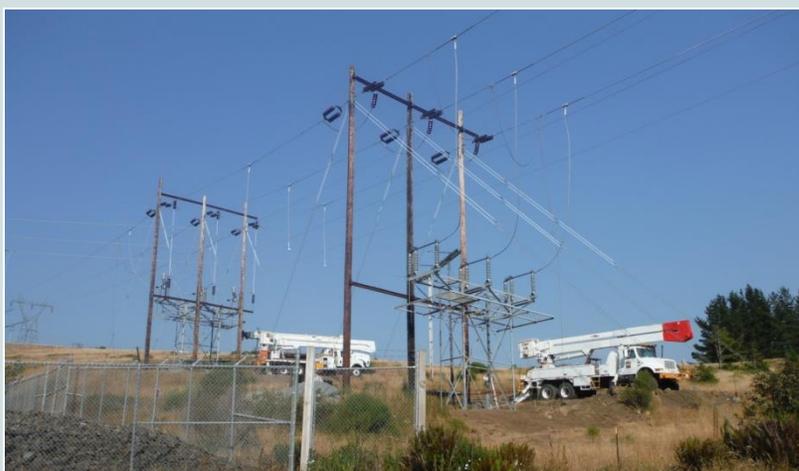
Wilson Construction Company Employee Fatality on the Bandon-Rogue No. 1 115kV Line, July 30, 2013

After examining the evidence and performing analysis of the identified events and causal factors, the Board found that the direct cause of the accident was that Crew Foreman 2 made contact with a difference of potential across the blade end insulator stack of B447.
