Accident Investigation Board Report

**Construction Accident at the Naval Reactors Facility  
June 17, 2012**

August 24, 2012

Naval Reactors Headquarters  
U.S. Department of Energy  
Washington, DC

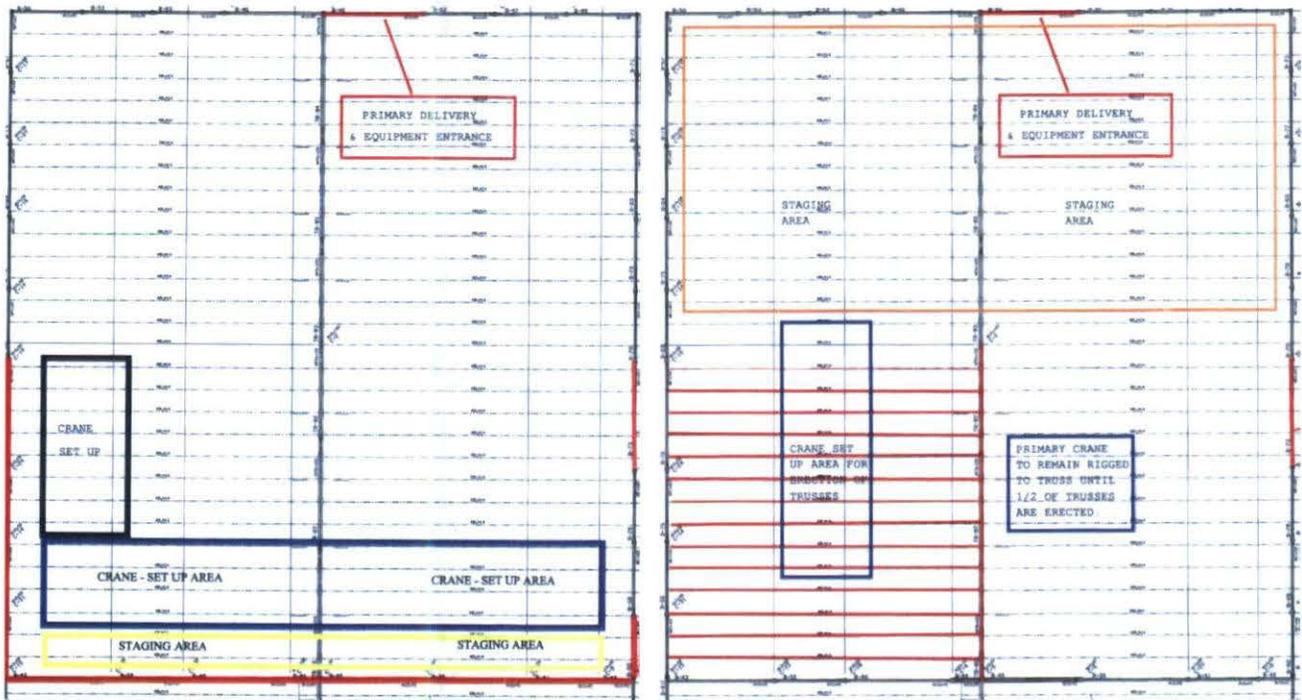
Figure 1: Sequences 1 and 2 of IEI Steel Erection Plan

As required by the construction specification, IEI, via Okland, submitted the Steel Erection Plan to BMPC for approval on April 30, 2012. BMPC approved IEI's Steel Erection Plan on June 11, 2012. IEI had the steel for the south wall and southwest quadrant erected and temporarily fastened in place by June 15, 2012. Figure 1 shows the erected steel highlighted in red. Work was stopped for the weekend in this condition, which was judged to be structurally stable as documented in the Steel Erection Plan.

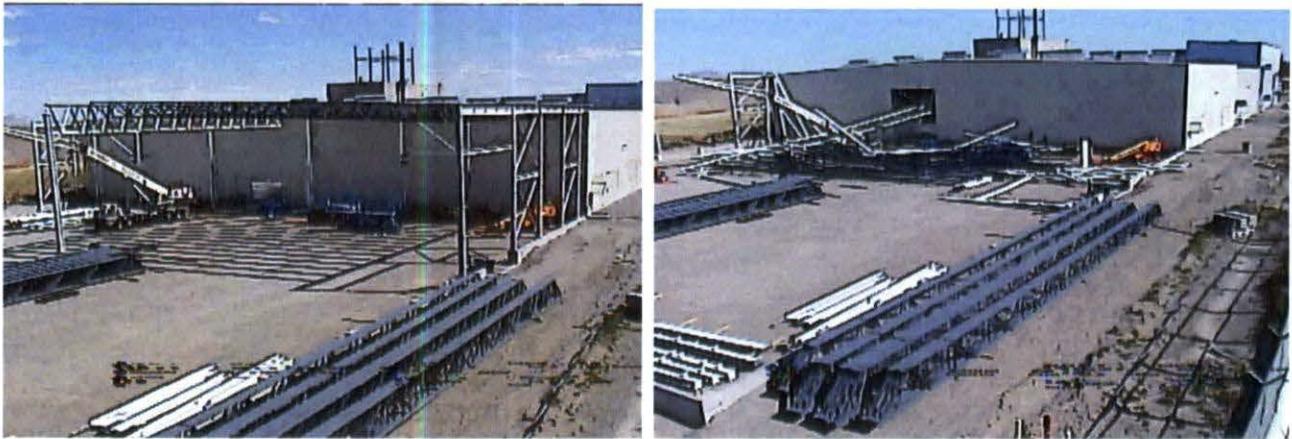
Figure 2: OSE2 photos before and after collapse

The partial structure collapsed on June 17, 2012 at 5:15 PM during a period of high winds. Based on data collected about 400 yards from OSE2, the sustained wind speed during this period was over 40 miles per hour with gusts over 60 miles per hour. Wind speeds of this magnitude are expected at NRF and are bounded by the specification requirement of 96 miles per hour. Figure 2 shows the partially-erect OSE2 structure before and after the collapse.

The structure collapsed because the horizontal loads imposed by the wind on June 17, 2012 exceeded the capacity of the partially-erected structure. The partial structure had cross bracing to resist horizontal loads on only two of the four sides, compared to all four sides for the finished structure. Evaluations performed after the collapse confirm that the partial structure could not resist the imposed wind loads; see Okland letter 7003268-F0041 dated July 9, 2012, BMPC letter B-EDOC-EASTMARS-2012-06-20 dated June 20, 2012, BMPC letter B-EDOC-EASTMARS-2012-06-21 dated June 21, 2012, Bechtel National Inc. Assessment for OSE #2 Building Collapse dated July 31, 2012, and Naval Facilities Engineering Command Structural Review dated July 30, 2012. For example, BMPC letter B-EDOC-EASTMARS-2012-06-20 dated June 20, 2012 shows that the stress created in the partial structure by 60 mile-per-hour wind, which is well below the 96 mile-per-hour design load, would exceed the partial structure's capacity by at least 50%. Evaluations demonstrate that the final structure will resist design wind loads; see Baker and Associates Engineering Design File BI-10970 dated March 9, 2011 and Naval Facilities Engineering Command Structural Review dated July 30, 2012.

- IEI incorrectly concluded that the partially-erect structure, without temporary bracing, would be stable under expected wind loads. IEI based this conclusion on judgment and experience with similar construction projects.

- IEI, Okland, and BMPC should evaluate and improve practices for generating and approving technical recommendations. The evaluations should specifically consider:

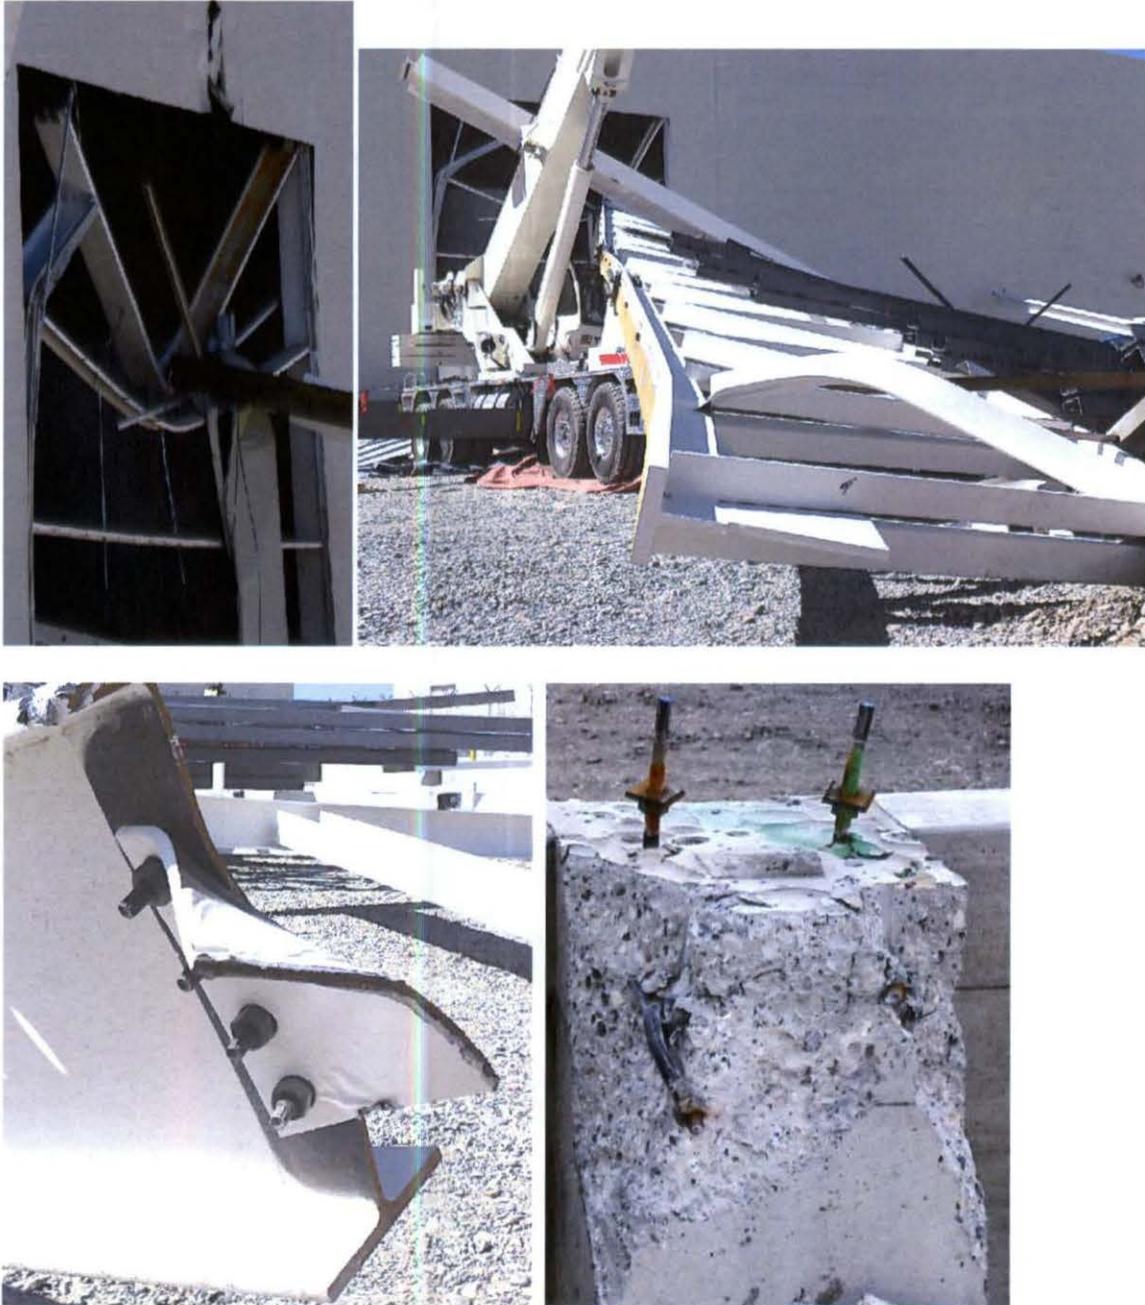
Figure 3: Examples of damage to OSE2 and adjacent building

No personnel were injured. The damage caused by the collapse was (see Figure 3 for examples):

- Sheet metal, sheet metal framing, and electrical cables in the adjacent overpack storage building were damaged, including visible bending and breakage.
- A contractor crane and two manlifts parked under the structure were damaged, including visible denting and crushing.
- The concrete and anchor studs in the foundations for about twenty columns were damaged, including visible concrete fractures and broken studs.
- About twenty structural columns and associated cross bracing, one main truss girder, and fourteen truss joists were damaged, including visible bending and breakage.
