Accident Investigation Board Report

**Construction Accident at the Naval Reactors Facility
June 17, 2012**

August 24, 2012

Naval Reactors Headquarters
U.S. Department of Energy
Washington, DC

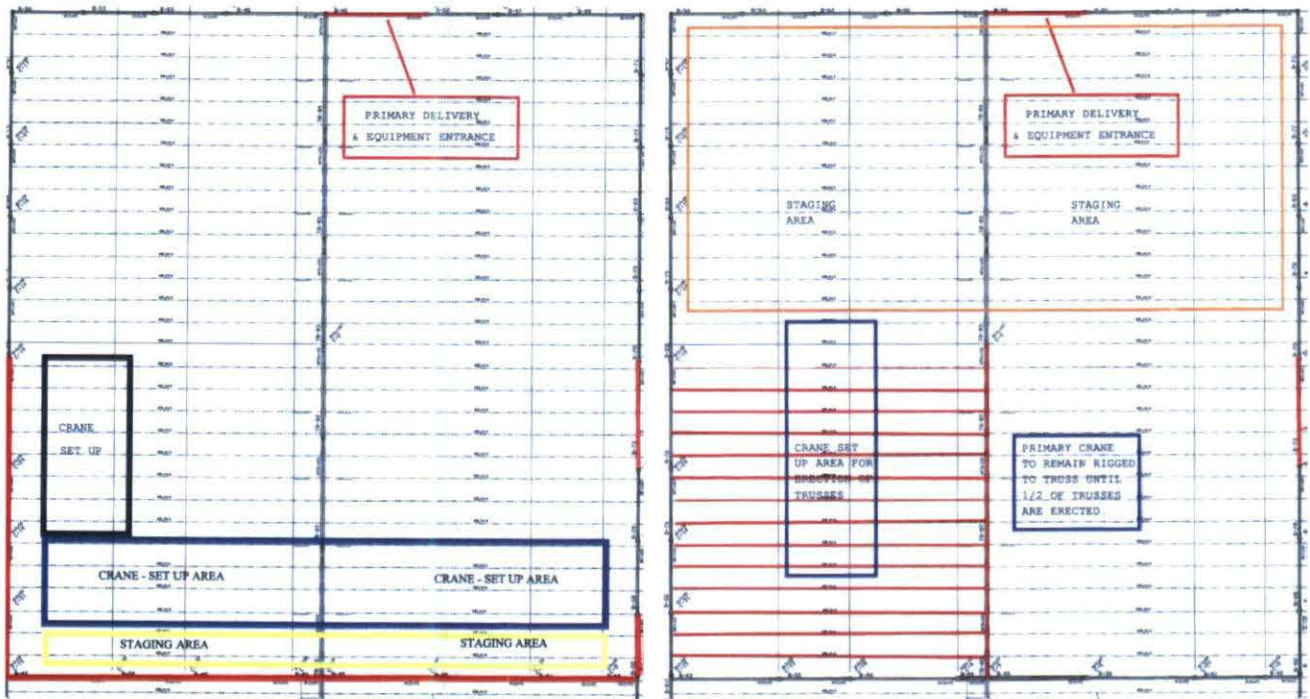
As required by the construction specification, IEI, via Okland, submitted the Steel Erection Plan to BMPC for approval on April 30, 2012. BMPC approved IEI's Steel Erection Plan on June 11, 2012. IEI had the steel for the south wall and southwest quadrant erected and temporarily fastened in place by June 15, 2012. Figure 1 shows the erected steel highlighted in red. Work was stopped for the weekend in this condition, which was judged to be structurally stable as documented in the Steel Erection Plan.

Figure 1: Sequences 1 and 2 of IEI Steel Erection Plan

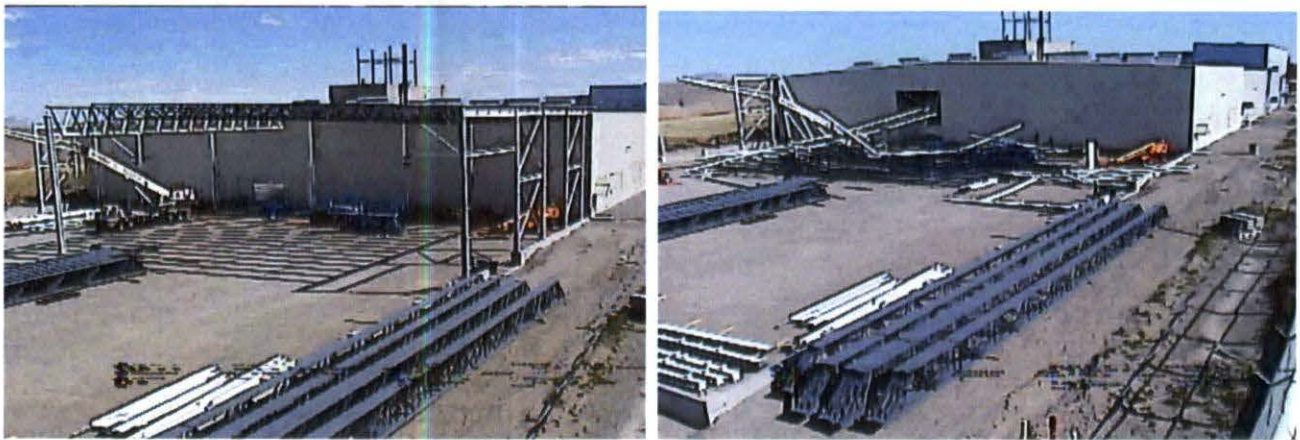
The partial structure collapsed on June 17, 2012 at 5:15 PM during a period of high winds. Based on data collected about 400 yards from OSE2, the sustained wind speed during this period was over 40 miles per hour with gusts over 60 miles per hour. Wind speeds of this magnitude are expected at NRF and are bounded by the specification requirement of 96 miles per hour. Figure 2 shows the partially-erect OSE2 structure before and after the collapse.

Figure 2: OSE2 photos before and after collapse

The structure collapsed because the horizontal loads imposed by the wind on June 17, 2012 exceeded the capacity of the partially-erected structure. The partial structure had cross bracing to resist horizontal loads on only two of the four sides, compared to all four sides for the finished structure. Evaluations performed after the collapse confirm that the partial structure could not resist the imposed wind loads; see Okland letter 7003268-F0041 dated July 9, 2012, BMPC letter B-EDOC-EASTMARS-2012-06-20 dated June 20, 2012, BMPC letter B-EDOC-EASTMARS-2012-06-21 dated June 21, 2012, Bechtel National Inc. Assessment for OSE #2 Building Collapse dated July 31, 2012, and Naval Facilities Engineering Command Structural Review dated July 30, 2012. For example, BMPC letter B-EDOC-EASTMARS-2012-06-20 dated June 20, 2012 shows that the stress created in the partial structure by 60 mile-per-hour wind, which is well below the 96 mile-per-hour design load, would exceed the partial structure's capacity by at least 50%. Evaluations demonstrate that the final structure will resist design wind loads; see Baker and Associates Engineering Design File BI-10970 dated March 9, 2011 and Naval Facilities Engineering Command Structural Review dated July 30, 2012.

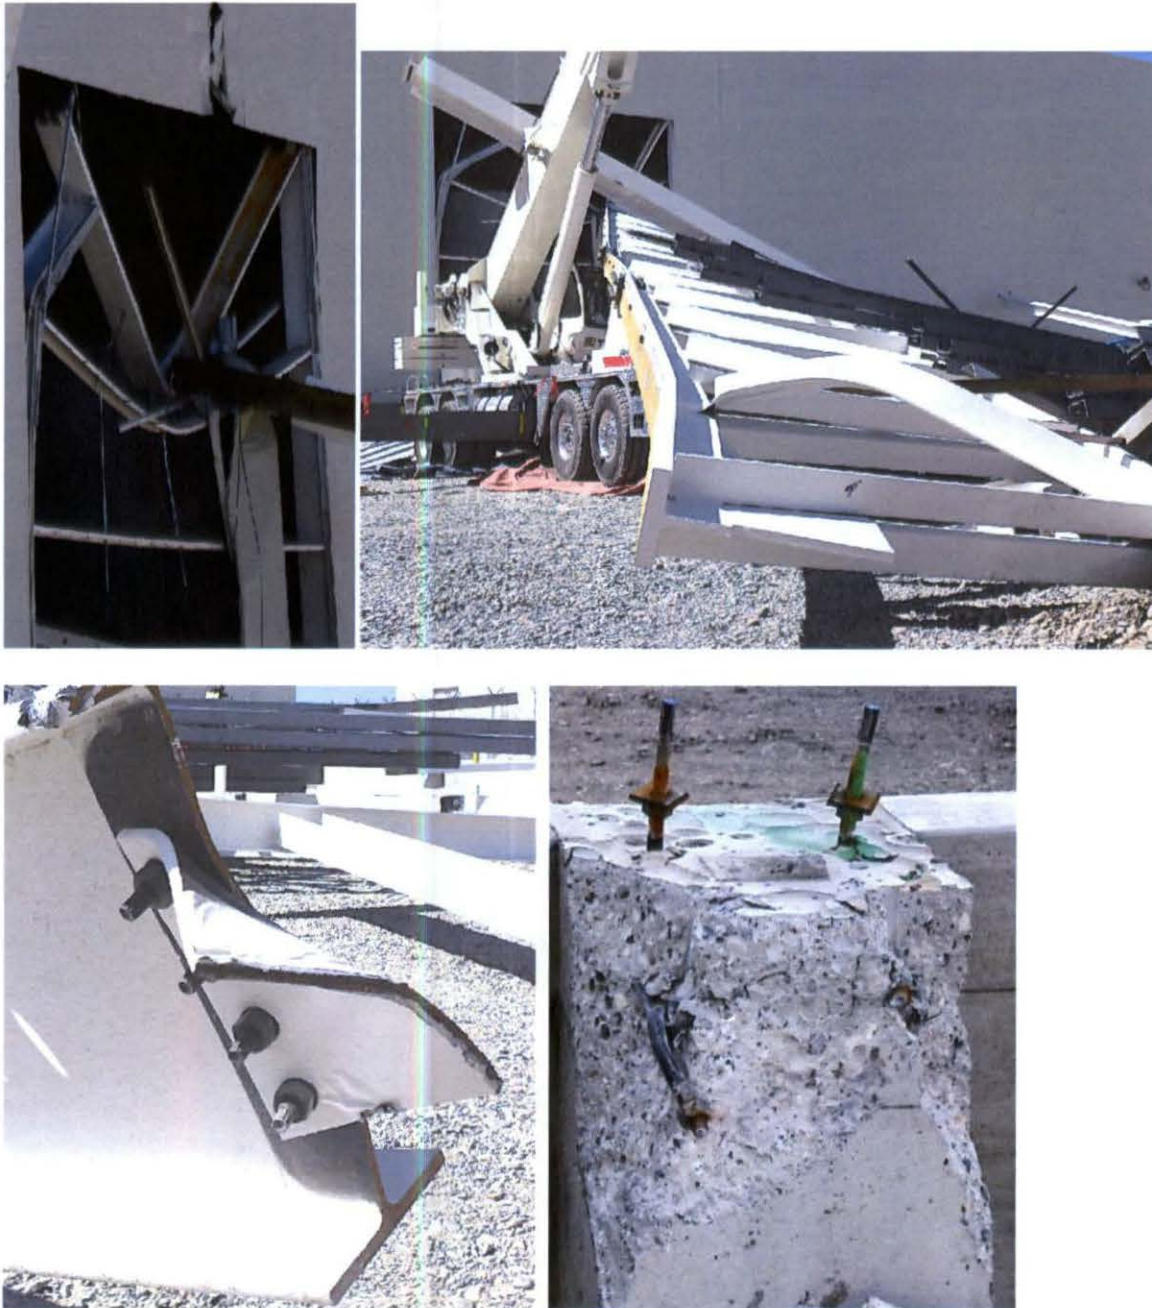
- Sheet metal, sheet metal framing, and electrical cables in the adjacent overpack storage building were damaged, including visible bending and breakage.
- A contractor crane and two manlifts parked under the structure were damaged, including visible denting and crushing.
- The concrete and anchor studs in the foundations for about twenty columns were damaged, including visible concrete fractures and broken studs.
- About twenty structural columns and associated cross bracing, one main truss girder, and fourteen truss joists were damaged, including visible bending and breakage.

Figure 3: Examples of damage to OSE2 and adjacent building
