# Hanford Lessons Learned/Operating Experience Information Bulletin

2009-RL-HNF-0040

## Man Lift Fatalities at Waltham Construction Site

**Date Published:** December 1, 2009

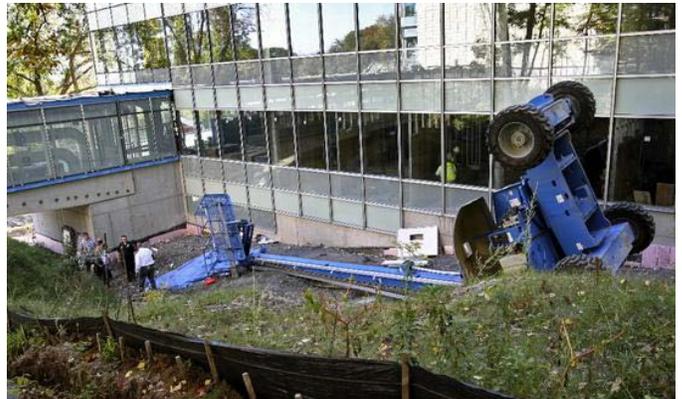
On October 10, 2008, two men were working on the east exterior façade utilizing the boom at the Waltham R&D site. The contractors began to reposition the boom uphill while standing on the platform with the arm extended, on an uneven slope, causing it to fall backwards, and resulting in the death of both individuals. Moving the boom lift while the boom is extended is not recommended per the Genie S85's operating manual.

- ◆ **The work area where the boom was operating was not level** – Lifts/booms should only operate on a suitable, firm, level surface.
- ◆ **Counter weight and extension boom positioned improperly** – The contractors began to reposition the boom uphill while standing on the platform with the arm extended, on an uneven slope. The counter weight was located on the downhill side, shifting the center of gravity to the downhill side, causing it to flip backwards.

- ◆ **Failure of tilt sensor and audible alarm** – The tilt sensor is specifically designed to alert the operator(s) in the lift basket, via audible alarm, when an unsafe condition (non-level working orientation) is being approached. The resulting OSHA investigation discovered that the Tilt Alarm been disconnected, although when and by whom was never fully understood.

- Only operate on suitable, firm and level surfaces
- Never operate drive system while boom in extended position
- Ensure Pre-Task planning accounts for all operating conditions and parameters related to the specific equipment being used
  - Includes review of equipment operations manual
  - Provides for pre-operation inspections, including safety systems integrity (e.g. tilt alarm is in proper working condition)
  - Incorporates review of specific site and area conditions
  - Ensures next, immediate user of borrowed equipment is responsible for its readiness for use
- Consider physical barriers to prevent boom lift movement in areas where unlevelled or unstable conditions are adjacent to planned work area
- Training should be specific to the type and model of equipment being utilized
- Robust maintenance and inventory program to ensure equipment is in appropriate working condition.
