HANFORD LESSONS LEARNED/OPERATING EXPERIENCE

Just-In-Time Report

2010-RL-HNF-0029

Loose Seams & Cuts Identified in PAPR Soft Hoods

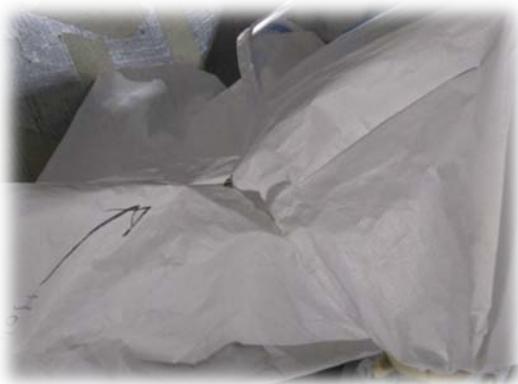
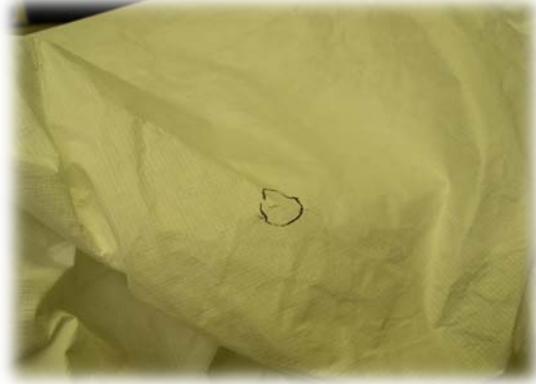
Several Mine Safety Appliance© (MSA) OptimAir TL Soft Hood PAPR's have been discovered with loose seam lines and significant splits in the Tyvek® hood material. In addition, small cuts have been observed on the back panels of the hood. According to the manufacturer, the cuts are a result of friction caused by the hose clamp bolt and material rubbing against each other and appear to have occurred during transport of the product.

- **The loose seam lines are primarily located in the left or right corner where the upper side piece and back lower piece are sewn together.**
- **The small cuts were discovered on the back panels of the hoods.**
- **MSA© has been contacted and the defective hoods have been sent back to the manufacturer.**

- **Friction between the hose clamp bolt and hood material during transport.**

Managers/Supervisors	Workers
<ul style="list-style-type: none">• Brief employees on this report to alert them to the risk of material/equipment.• Ensure Respirators are inspected prior to use in the field.	<ul style="list-style-type: none">• If a cut, tear or loose seam is observed, contact your project Respiratory Protection Subject Matter Expert, Industrial Hygienist or Respiratory Protection Program administrator.
