Level I Accident Investigation
Report
March 1, 2010
Fatal Bobcat/Backhoe Accident
At the White Bluffs Substation

**Report Date:
March 31, 2010**

BPA
Level I Bobcat/Backhoe Accident, March 1, 2010 at White Bluffs Substation
Final Report

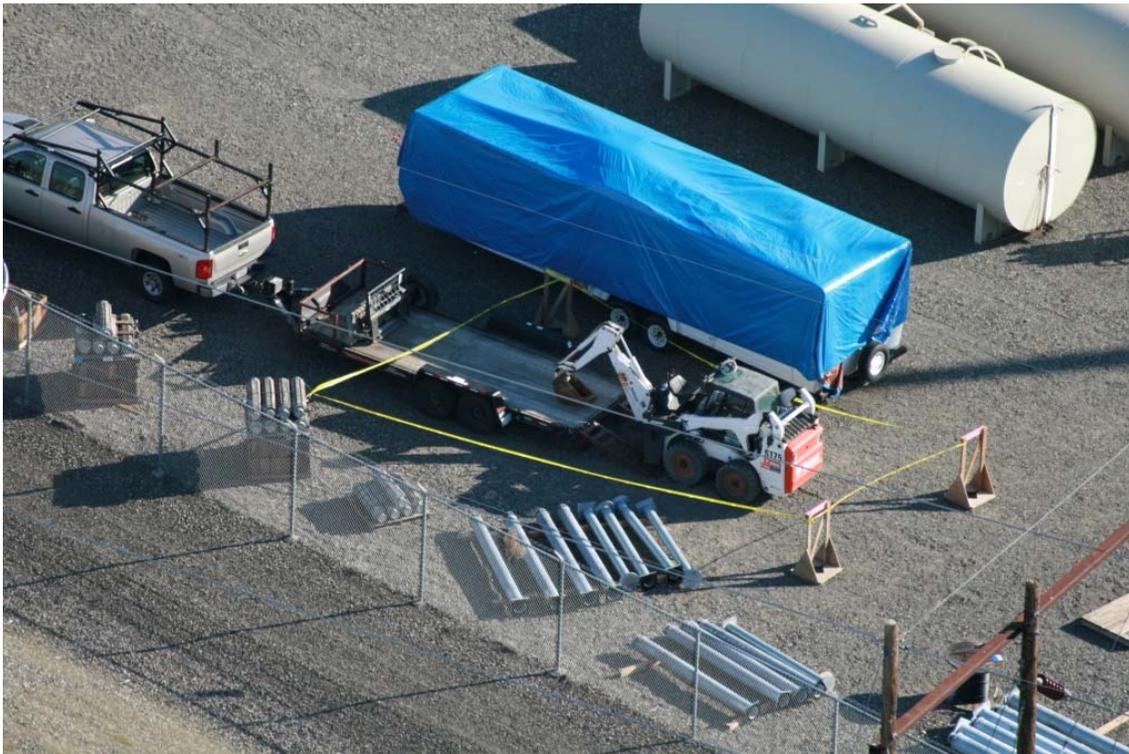
Figure 1-1: Aerial View of Accident Scene

On March 1, 2010, at approximately 0850, a Christenson Electric, Inc (Christenson) employee was fatally injured at the Bonneville Power Administration's (BPA) White Bluffs Substation near Richland, Washington while loading a BPA-owned Bobcat equipped with a backhoe attachment onto a trailer for transport to another work site. The accident occurred as the Contract Heavy Equipment Operator, now referred to as CHEO, moved into a position between the Bobcat Roll Over Protection Structure (ROPS) cage and the backhoe attachment; lowered the seat bar, bypassing the BICS™; and engaged the hydraulic systems which caused the Bobcat lift arms to raise the backhoe attachment, pinning the CHEO between the backhoe attachment seat and the Bobcat ROPS.

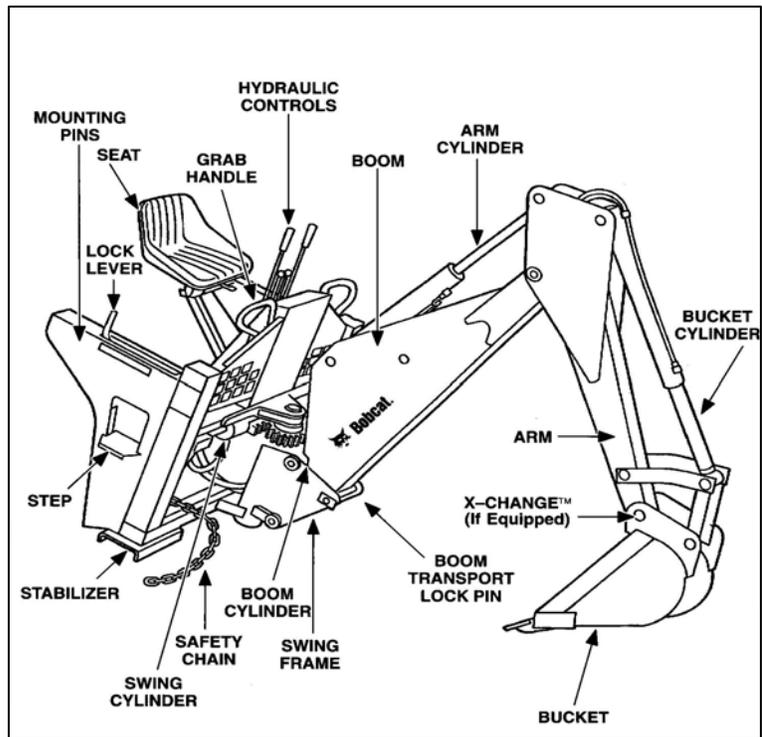
Figure 2-2: Backhoe Attachment

A Bobcat backhoe attachment is a piece of excavating equipment consisting of a digging bucket on the end of a two-part articulated arm. It mounts on the front of the Bobcat using the “Bob-Tach” system. The boom is closest to the Bobcat and the section that carries the bucket is known as the arm. The seat and controls for the functions of the backhoe attachment are independent of the Bobcat. See Figure 2-2 for backhoe nomenclature.

The AIB requested a Bobcat factory representative to conduct an operational and functional inspection of the Bobcat and backhoe attachment. Bobcat sent a Senior Product Design and Safety Engineer to perform the requested inspection. The Bobcat representative subsequently submitted a written report to the AIB. Based upon this report, the AIB concluded that the Bobcat and backhoe attachment involved in this accident were in good working order and were not a contributing cause to this accident.

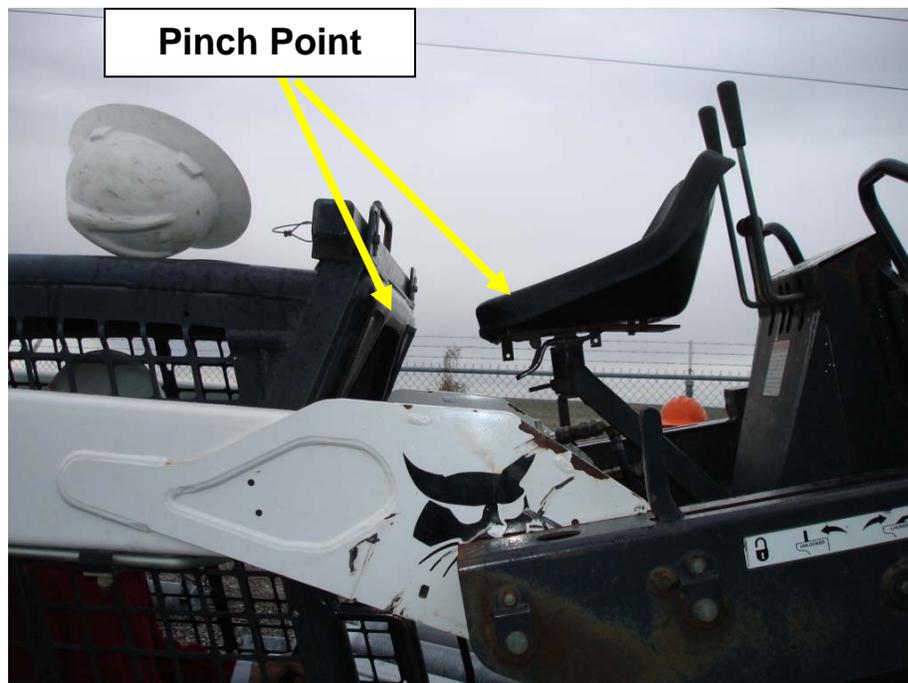
Figure 2-3: Pinch Point Between Bobcat and Backhoe Attachment

The CHEO again re-entered the machine, and either remained standing, put the seat bar down and activated the BICS™ system or, put the seat bar down, sat on the bar and activated the BICS™. The CHEO reached for the backhoe seat to either pull from a seated position or, hold on to the backhoe seat for support. In either case, the CHEO depressed the left foot hydraulic pedal which resulted in the Bobcat lift arms being raised, pinning the CHEO between the backhoe attachment seat and the ROPS of the Bobcat. The CL1 turned off the Bobcat and summoned the crew for assistance.

Causal factors consist of direct, root and contributing causes. A direct cause is the immediate event or condition that caused the accident. The AIB concluded that the direct cause of this accident was the CHEO activated the hydraulic controls while standing in the pinch point.

The root causes of the accident are the fundamental causes that, if corrected, would prevent recurrence of this and similar accidents. The AIB concluded that the root cause of this accident was that the CHEO bypassed the Bobcat safety features. The AIB also identified contributing causes that are events or conditions that, collectively with the other causes, increase the likelihood of the accident, but individually did not cause the accident. The AIB concluded that a contributing cause of this accident was the CHEO did not receive a sufficient J-1 (pre-job briefing that included work planning, job hazards analysis, and controls). Interview with the BCFMI and a review of the written J-1 the day of the accident indicate that the briefing the CHEO received, an hour after the crew's job briefing, was verbal and only included assignment of job tasks associated with moving tools and equipment to a new job site.

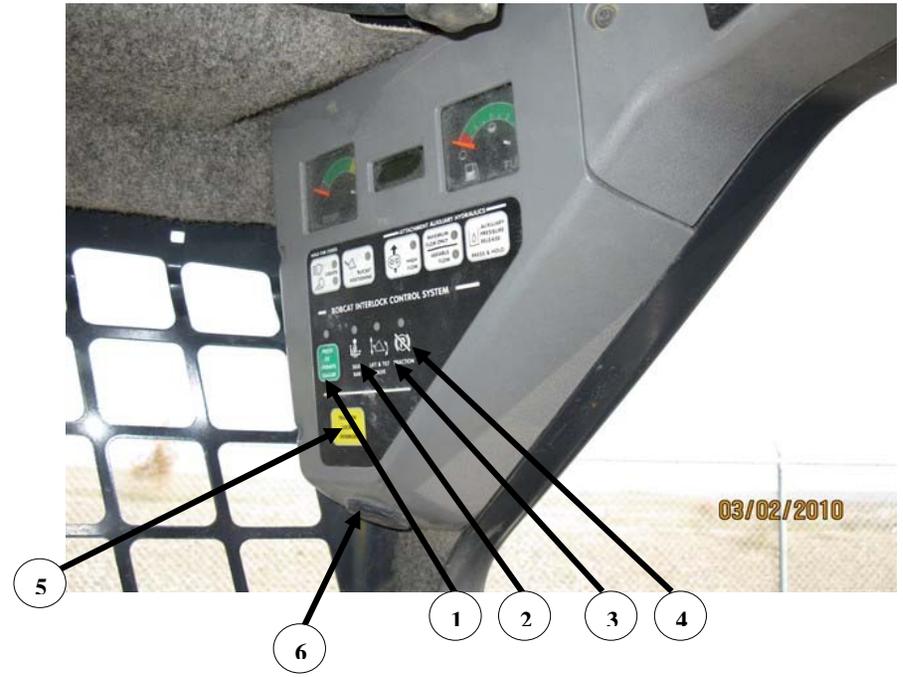
Figure D-1: Bobcat Interlock Control System (BICS™)

The Bobcat S175 is equipped with a safety interlock system, the Bobcat Interlock Control System (BICS™). To activate the hydraulic lift/tilt functions, the BICS™ requires the seat bar to be in the lowered position, the engine running, and the “press to operate loader” button pushed. See Appendix D: Bobcat Interlock Control System.
