**Type A Accident
Investigation Board Report
on the February 13, 1997,
Welding/Cutting Fatality
at the
K-33 Building, K-25 Site
Oak Ridge, Tennessee**

**Type A Accident
Investigation Board Report
of the February 13, 1997
Welding/Cutting Fatality
at the
K-33 Building, K-25 Site
Oak Ridge, Tennessee**

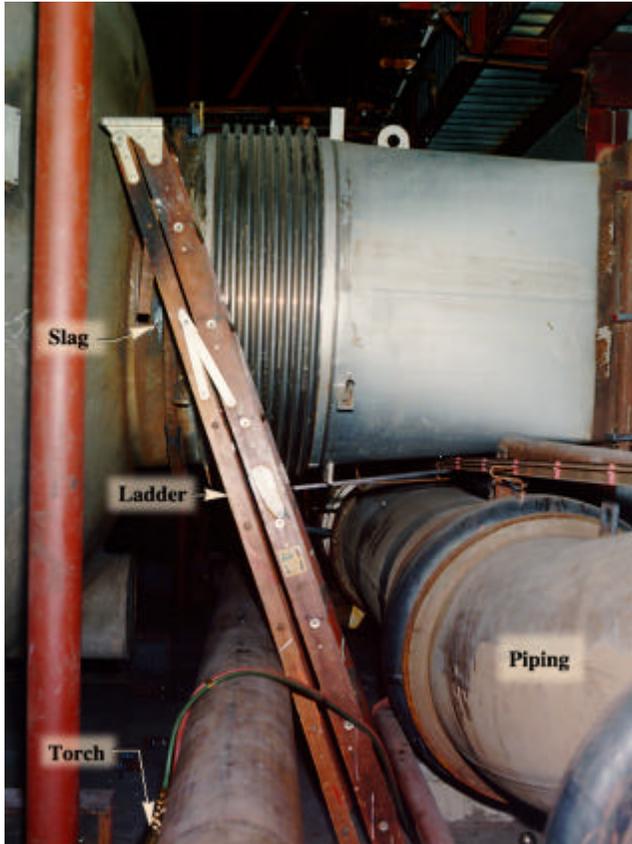
Exhibit 2-2. East End of Converter 4

The Welder was using a cutting torch to remove one of the six remaining process converters and, at the time of the accident, was working on a ladder at the east end of Converter 4 (see Exhibit 2-2).

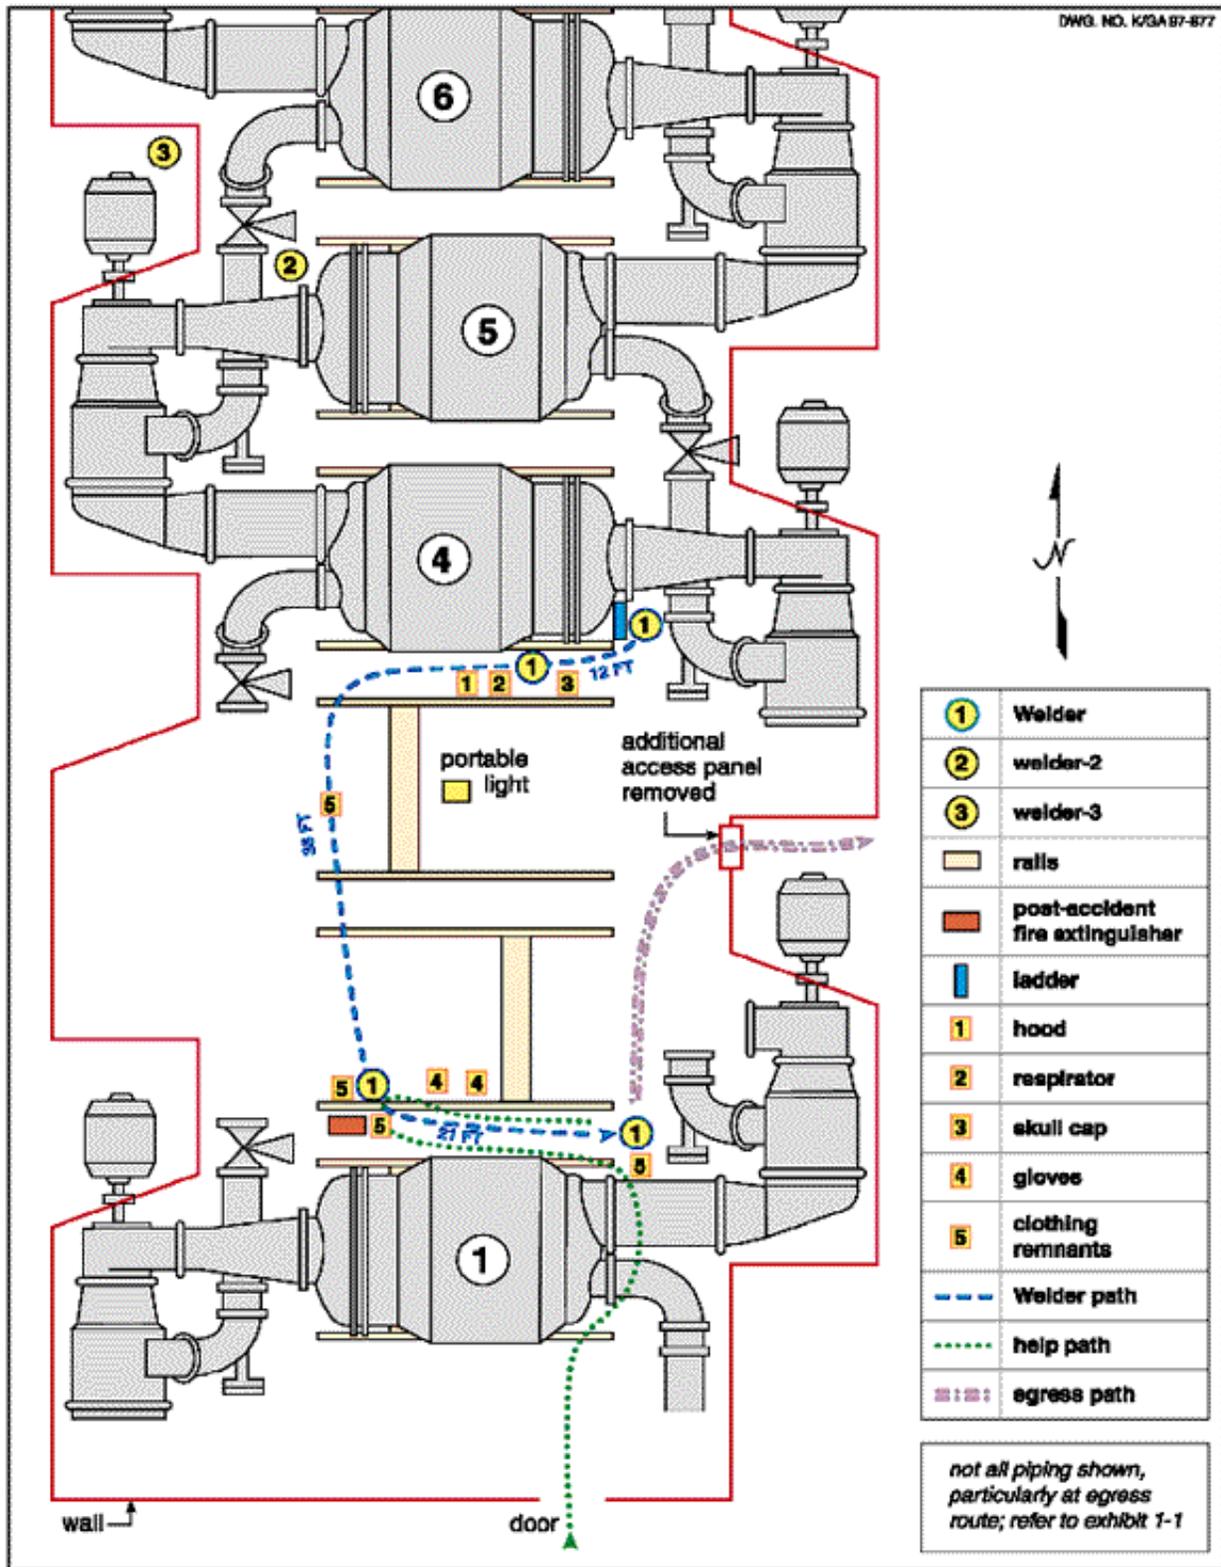
Figure 2-1. The Welder's Location and Movement Within Cell No. 7

Obstacles in the cell and building hampered removal of the Welder to the ambulance.

The overall quality of the accident response effort on February 13, 1997, was satisfactory and provided the Welder opportunity for survival, if his burn wounds had not been so extensive. However, egress from Cell 7 was problematic because of poor illumination and the confined nature of the work site. The difficult extraction from the cell/building accounted for delay in transport to the Medical Center. Twenty minutes of the rescue time were spent getting patient-removal gear to Cell 7 and maneuvering the stretcher-borne, 215-pound Welder over and under pipes. A nearby cell panel opening also had to be enlarged for egress. Without the obstacles, the egress difficulties from Cell 7, the physical distances involved, and the lack of basic first-aid gear in the building, the extraction time could have been shortened by approximately ten minutes.

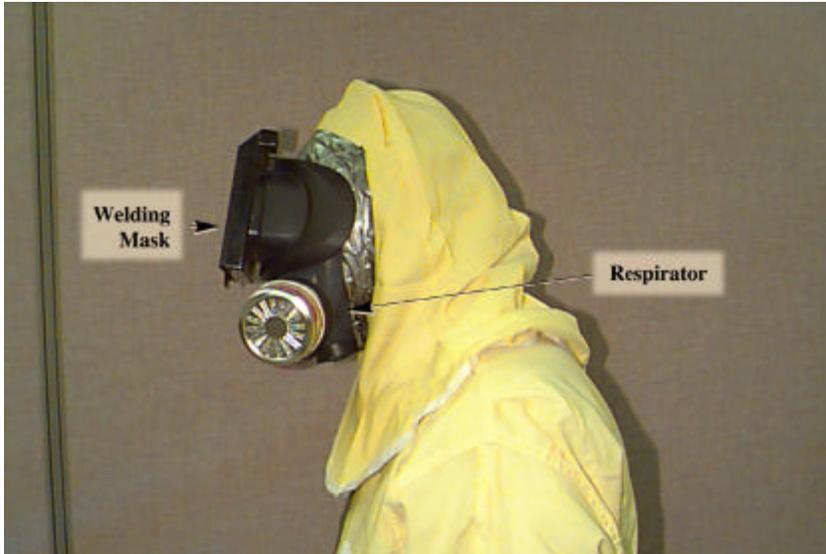
Exhibit 2-3. Welder's Outfit with Hood and Respirator (Closeup)

At the time of the accident, the Welder was wearing one set of underwear, one set of 100 percent cotton blue general-purpose coveralls, two sets of 100 percent cotton yellow anti-contamination coveralls, one pair of cotton liner gloves, one pair

At the time of the accident, the Welder was wearing three sets of coveralls, three pairs of gloves, four covers over safety shoes, a skull cap and hood, a personal air monitor, and a full-face respirator with an attached welding
