**Type A Accident  
Investigation Board Report  
on the February 13, 1997,  
Welding/Cutting Fatality  
at the  
K-33 Building, K-25 Site  
Oak Ridge, Tennessee**

This document presents a management-level summary of the *Type A Accident Investigation Board Report of the February 13, 1997, Welding/Cutting Fatality at the K-33 Building, K-25 Site, Oak Ridge, Tennessee*. The referenced report provides a much higher level of detail and includes a complete presentation of the facts identified, the analysis of these facts, conclusions derived from that analysis, identification of the causal factors underlying the accident, and specification of judgments of need that should be addressed through follow-up action by DOE and its contractors. This companion document provides a more concise review of the facts and conclusions of that report, with special emphasis on management issues arising from the investigation.

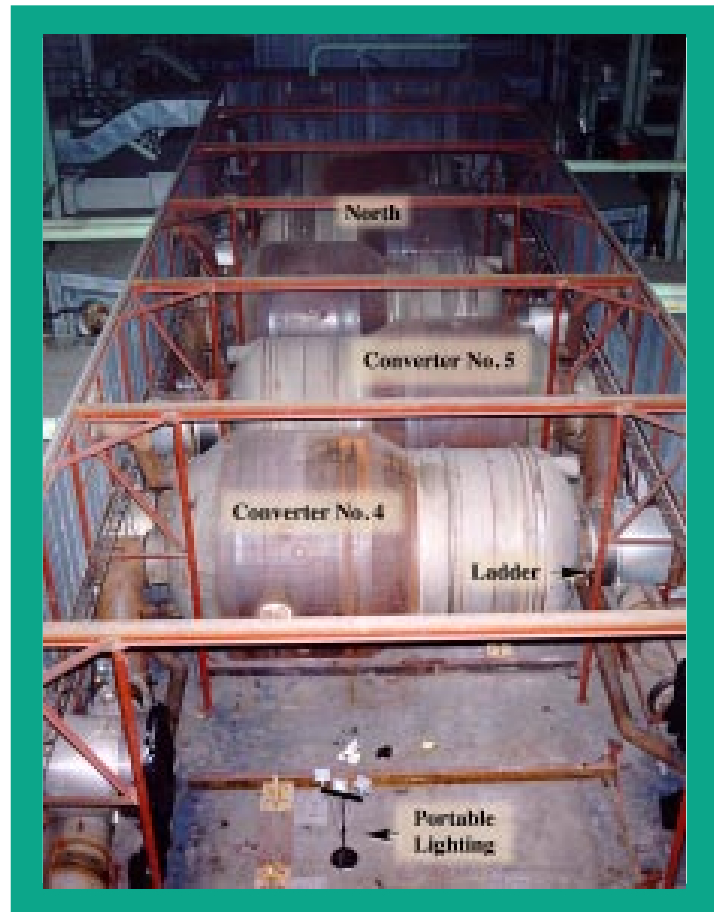
**Exhibit 1. View Looking North in Cell 7, K-33 Building**

The accident occurred at approximately 11:10 a.m. on Thursday, February 13, 1997, at the K-33 Building. The work involved the removal from Cell 7 of six converters scheduled to be shipped to Portsmouth and/or Paducah as spare parts. Exhibit 1 shows a view of the cell where the work was being performed. Although the cell's roof was removed, the lighting in the cell was very poor, and temporary lighting was installed. The physical layout of the equipment in the cell required the welders to work in a constricted space, with very difficult ingress and egress. Converters 2 and 3 had already been removed, and the welder was performing a cutting operation on Converter 4, near the location of the ladder in the photograph, when a spark or a piece of hot metal ignited his anti-contamination coveralls at, or somewhat below, his left knee.

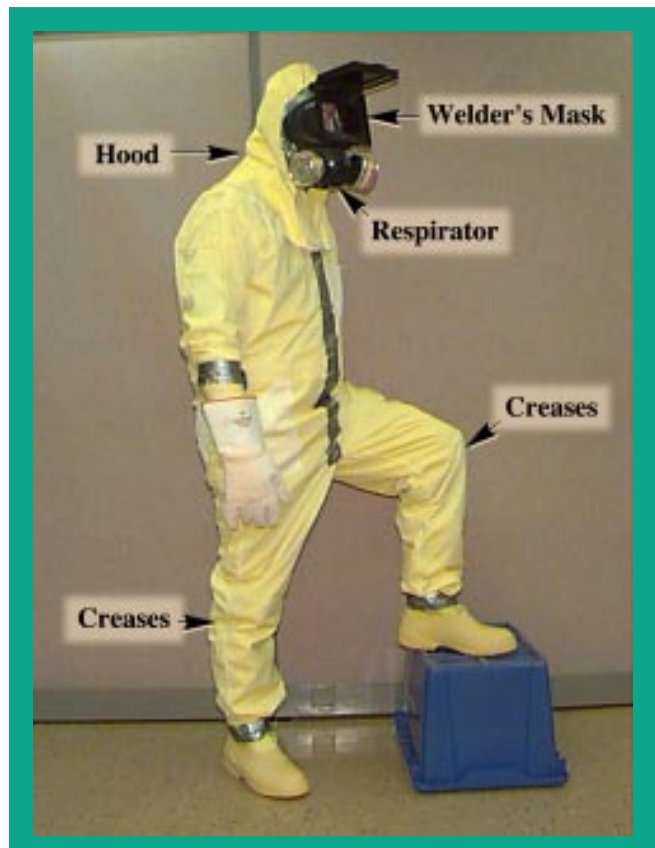
Exhibit 2. Similarly Outfitted Welder

A Radiological Work Permit issued for the converter removal effort required the use of anti-contamination clothing and a respirator. However, the Board found that neither DOE nor LMES policies require the use of flame-retardant anti-contamination clothing for welding, cutting, or hotwork operations. Exhibit 2 is a photograph of a worker dressed in personal protective equipment similar to that worn by the welder at the time of the accident. As shown in this illustration, the welder's senses of sight and smell would have been severely limited by his mask and the respirator. In addition, the multiple layers of protective clothing would have allowed a fire to burn for some time before the

ensuing heat could be felt. Testing conducted by the Board indicated that there would have been a 65- to -80 second delay before the welder could have detected the ignition of his clothing. After 90 seconds, the flame could not have been extinguished by the welder alone. The Board found that concerns regarding a possible contamination hazard may have caused the use of a level of protective equipment that impeded worker response to the actual, but unrecognized, hazard of clothing ignition.

The Board concluded that the designation of a fire watch with clear personnel safety responsibilities and/or the use of flame-retardant anti-contamination clothing by the welder would have prevented this fatality. However, as noted below, the Board determined that significant deficiencies must be corrected both in management identification of accident precursors and in the LMES work planning and control program to prevent recurrence of a similar accident.

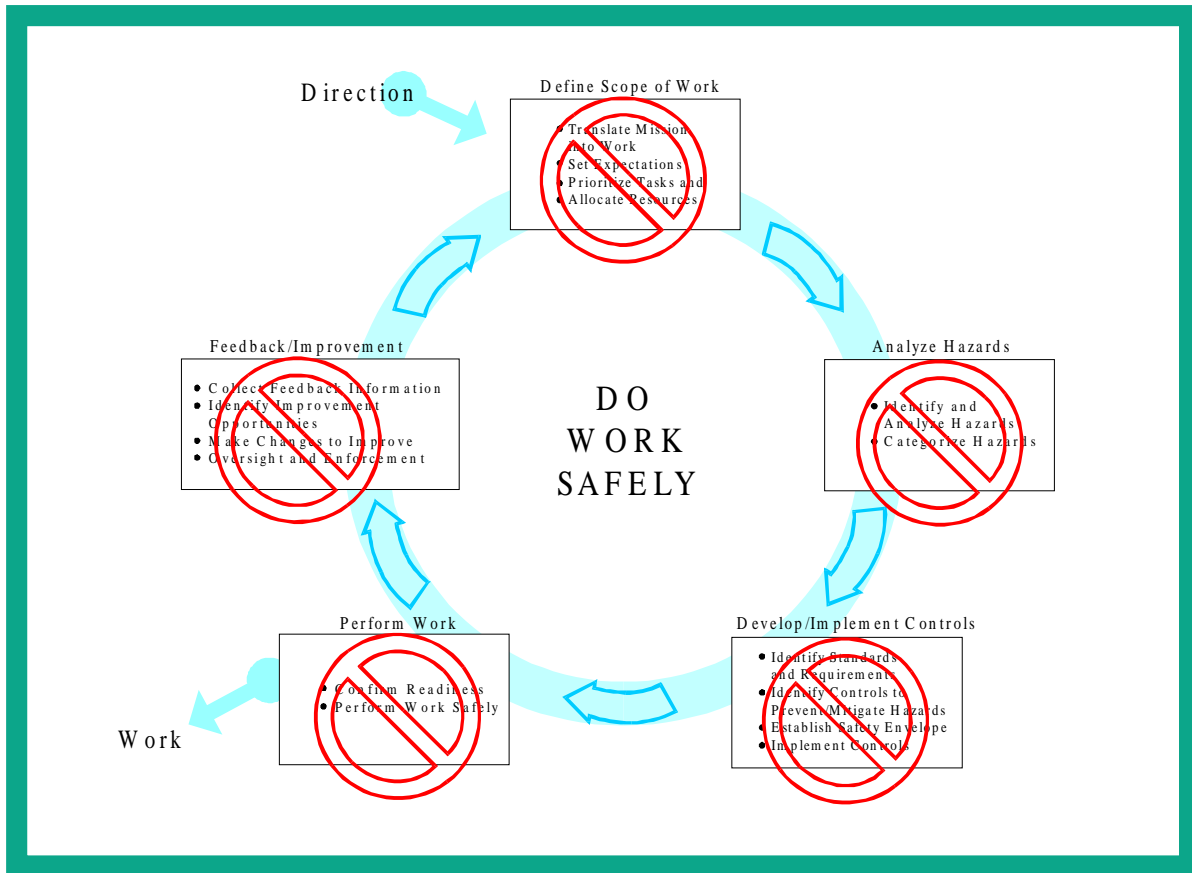
**Figure 2. Core Safety Management Functions as Implemented**

An analysis of the facts from this accident investigation leads to the conclusion that the maintenance work planning process and associated controls for the K-33 converter removal work were not adequate. Figure 2 illustrates the five core safety management functions as implemented for this job.

The absence of clearly defined line management responsibility and accountability for safety caused failures in translating the job mission into safe work practices, in setting safety expectations, and in allocating trained and experienced personnel to the effort. Since line management did not ensure that an adequate Job Hazards Analysis was completed before the work began, measures and controls to mitigate the hazards were not developed or implemented. This, in turn, caused the work to be performed without appropriate controls. The requirements for this process were specified in LMES instructions and K-25 Site procedures, but were not implemented during the work. Furthermore, lessons learned from previous work were not adequately evaluated, documented, or incorporated into the planning for K-33 converter removal work. If the problems that workers had previously experienced with anti-contamination clothing catching on fire had been adequately analyzed, and if the lessons learned had been documented, communicated, and appropriately incorporated into the planning for K-33 converter removal work, the accident might have been avoided. More fundamentally, weaknesses in the safety management system allowed the welder's safety to depend on the single mitigating factor of a property-protection-oriented fire watch that was required, but not routinely implemented.
