**Type A Accident  
Investigation Board Report  
on the February 13, 1997,  
Welding/Cutting Fatality  
at the  
K-33 Building, K-25 Site  
Oak Ridge, Tennessee**

This document presents a management-level summary of the *Type A Accident Investigation Board Report of the February 13, 1997, Welding/Cutting Fatality at the K-33 Building, K-25 Site, Oak Ridge, Tennessee*. The referenced report provides a much higher level of detail and includes a complete presentation of the facts identified, the analysis of these facts, conclusions derived from that analysis, identification of the causal factors underlying the accident, and specification of judgments of need that should be addressed through follow-up action by DOE and its contractors. This companion document provides a more concise review of the facts and conclusions of that report, with special emphasis on management issues arising from the investigation.

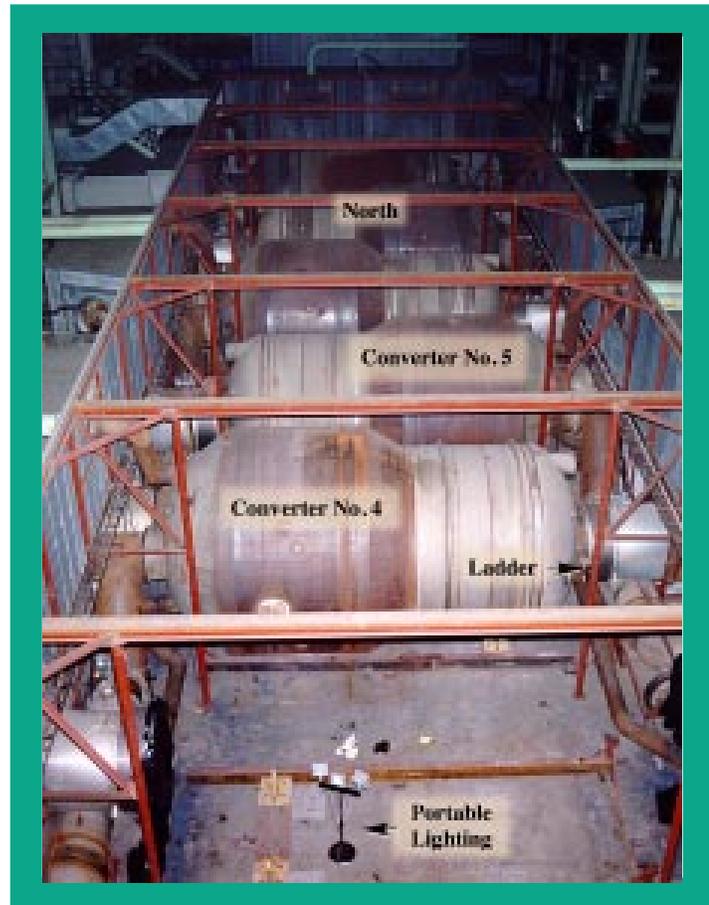
**Exhibit 1. View Looking North in Cell 7, K-33 Building**

The accident occurred at approximately 11:10 a.m. on Thursday, February 13, 1997, at the K-33 Building. The work involved the removal from Cell 7 of six converters scheduled to be shipped to Portsmouth and/or Paducah as spare parts. Exhibit 1 shows a view of the cell where the work was being performed. Although the cell's roof was removed, the lighting in the cell was very poor, and temporary lighting was installed. The physical layout of the equipment in the cell required the welders to work in a constricted space, with very difficult ingress and egress. Converters 2 and 3 had already been removed, and the welder was performing a cutting operation on Converter 4, near the location of the ladder in the photograph, when a spark or a piece of hot metal ignited his anti-contamination coveralls at, or somewhat below, his left knee.

At the time of the accident, the welder was wearing multiple layers of clothing that were not flame-retardant and radiological protective equipment that limited his ability to detect and extinguish the flames quickly. Since the welder was working alone, the flames spread undetected until they were beyond the welder's ability to extinguish them without assistance. By the time a co-worker responded to the emergency and extinguished the fire with a dry chemical fire extinguisher, flames had totally engulfed the welder's body. At approximately 11:46 a.m., he was transported by ambulance to Methodist Medical Center in Oak Ridge, arriving at noon. The welder suffered third degree burns over 95 percent of his body. He was transferred to the Erlanger Burn Center in Chattanooga and died at 10:41 a.m. on February 14, 1997.

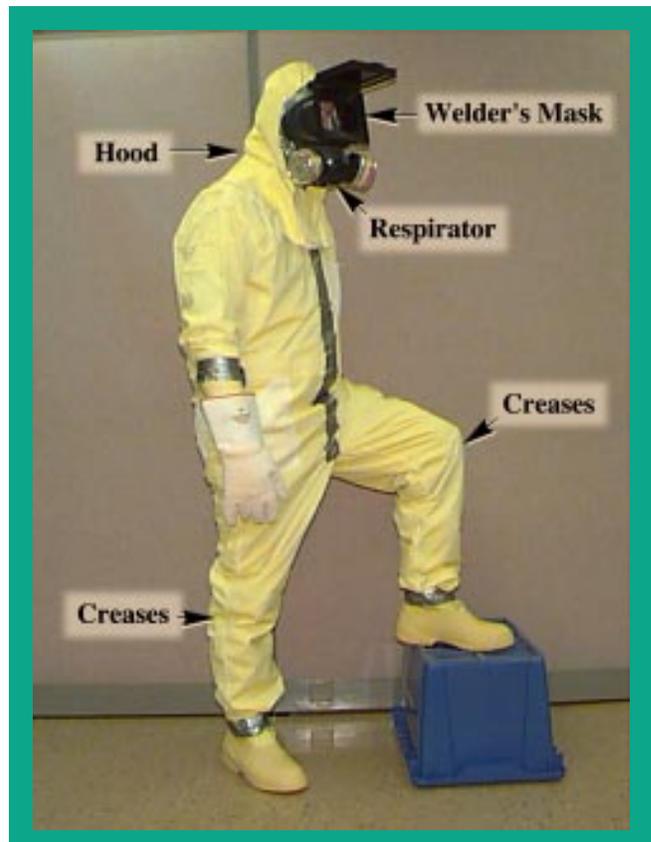
Exhibit 2. Similarly Outfitted Welder

A Radiological Work Permit issued for the converter removal effort required the use of anti-contamination clothing and a respirator. However, the Board found that neither DOE nor LMES policies require the use of flame-retardant anti-contamination clothing for welding, cutting, or hotwork operations. Exhibit 2 is a photograph of a worker dressed in personal protective equipment similar to that worn by the welder at the time of the accident. As shown in this illustration, the welder's senses of sight and smell would have been severely limited by his mask and the respirator. In addition, the multiple layers of protective clothing would have allowed a fire to burn for some time before the

ensuing heat could be felt. Testing conducted by the Board indicated that there would have been a 65- to -80 second delay before the welder could have detected the ignition of his clothing. After 90 seconds, the flame could not have been extinguished by the welder alone. The Board found that concerns regarding a possible contamination hazard may have caused the use of a level of protective equipment that impeded worker response to the actual, but unrecognized, hazard of clothing ignition.

The Board concluded that the designation of a fire watch with clear personnel safety responsibilities and/or the use of flame-retardant anti-contamination clothing by the welder would have prevented this fatality. However, as noted below, the Board determined that significant deficiencies must be corrected both in management identification of accident precursors and in the LMES work planning and control program to prevent recurrence of a similar accident.

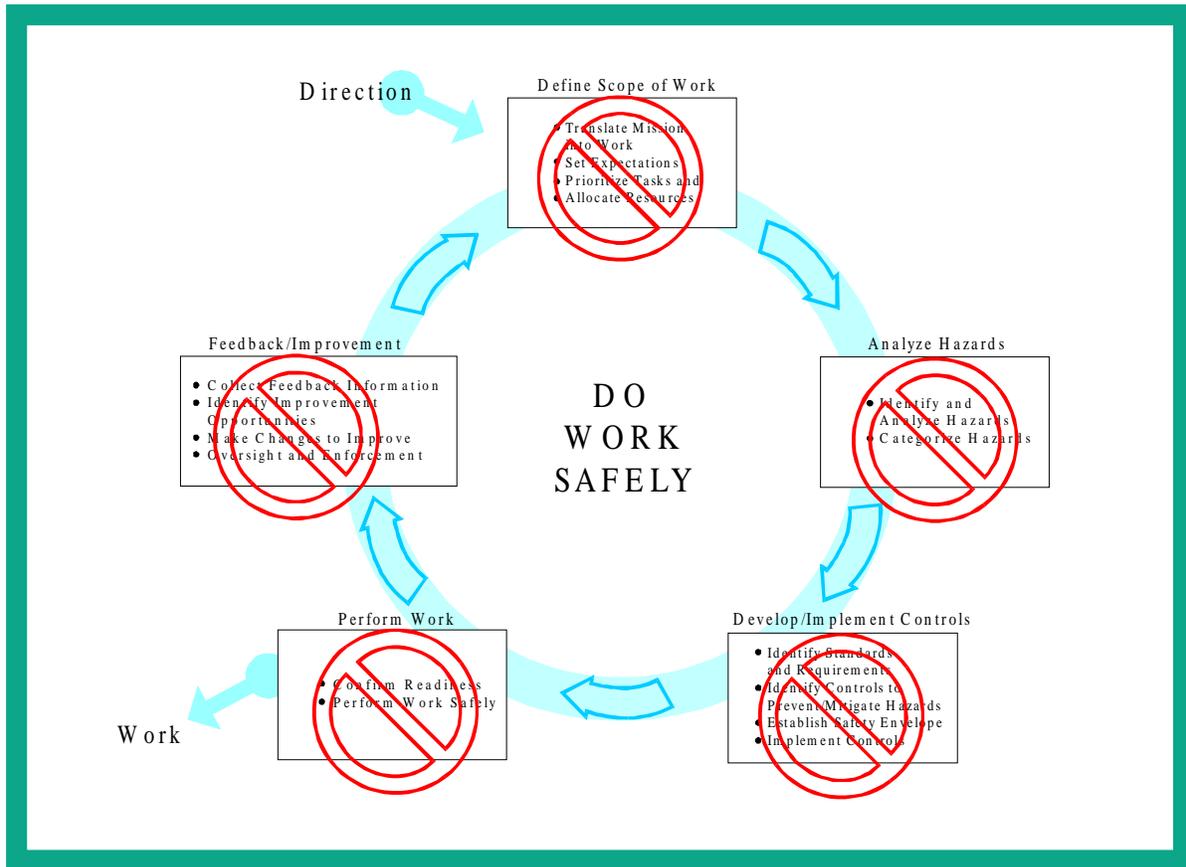
**Figure 2. Core Safety Management Functions as Implemented**

An analysis of the facts from this accident investigation leads to the conclusion that the maintenance work planning process and associated controls for the K-33 converter removal work were not adequate. Figure 2 illustrates the five core safety management functions as implemented for this job.

The absence of clearly defined line management responsibility and accountability for safety caused failures in translating the job mission into safe work practices, in setting safety expectations, and in allocating trained and experienced personnel to the effort. Since line management did not ensure that an adequate Job Hazards Analysis was completed before the work began, measures and controls to mitigate the hazards were not developed or implemented. This, in turn, caused the work to be performed without appropriate controls. The requirements for this process were specified in LMES instructions and K-25 Site procedures, but were not implemented during the work. Furthermore, lessons learned from previous work were not adequately evaluated, documented, or incorporated into the planning for K-33 converter removal work. If the problems that workers had previously experienced with anti-contamination clothing catching on fire had been adequately analyzed, and if the lessons learned had been documented, communicated, and appropriately incorporated into the planning for K-33 converter removal work, the accident might have been avoided. More fundamentally, weaknesses in the safety management system allowed the welder's safety to depend on the single mitigating factor of a property-protection-oriented fire watch that was required, but not routinely implemented.
