DOE ACCIDENT PREVENTION AND INVESTIGATION

Bi-Annual Summary Report

U.S. Department of Energy ▪ Office of Health, Safety and Security ▪ AI-2010-01 ▪ April 23, 2010

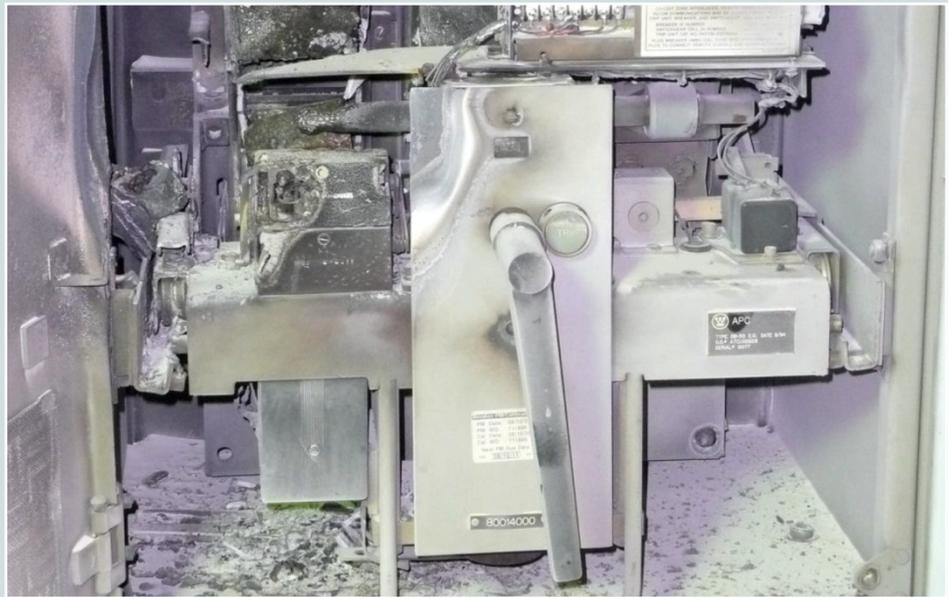
Type B Accident Investigation

Employee Burn Injury
at the D Area Powerhouse

September 23, 2009

Employee Burn Injury at the D Area Powerhouse, September 23, 2009, Savannah River Site ([ORPS Event EM-SR-SRNS-SIPS-2009-0008](#)) — While troubleshooting in a 480 volt breaker cubicle, an electrical and instrumentation (E&I) mechanic received second and third degree burns to his arms and first and second degree burns to his face when a metal tool (9-inch torpedo level) contacted the energized "A" phase of the breaker causing a direct short to ground and arc flash event. The tool had been placed in the energized cabinet by a second E&I mechanic as part of troubleshooting activities to determine the extent of “adjustments” needed to align the breaker within the cabinet.

Procedurally, the breaker cubicle was of a sufficient arc flash hazard category that work in the vicinity of the cubicle was not allowed with the cubicle door open and the conductors energized. In addition, neither E&I mechanic was wearing arc flash suits or flame retardant coveralls with face shields that are normally required for working within the vicinity of energized switchgear. Immediate supervision was aware of ongoing troubleshooting and repair with the equipment energized.

The Board determined the Direct Cause as “Metal torpedo level fell and came into contact with Phase ‘A’ of an energized 480 volt breaker.”

The Board determined the Root Cause as “Experienced Qualified Electrical Workers (QEW) failed to comply with required and expected safe electrical work practices.”

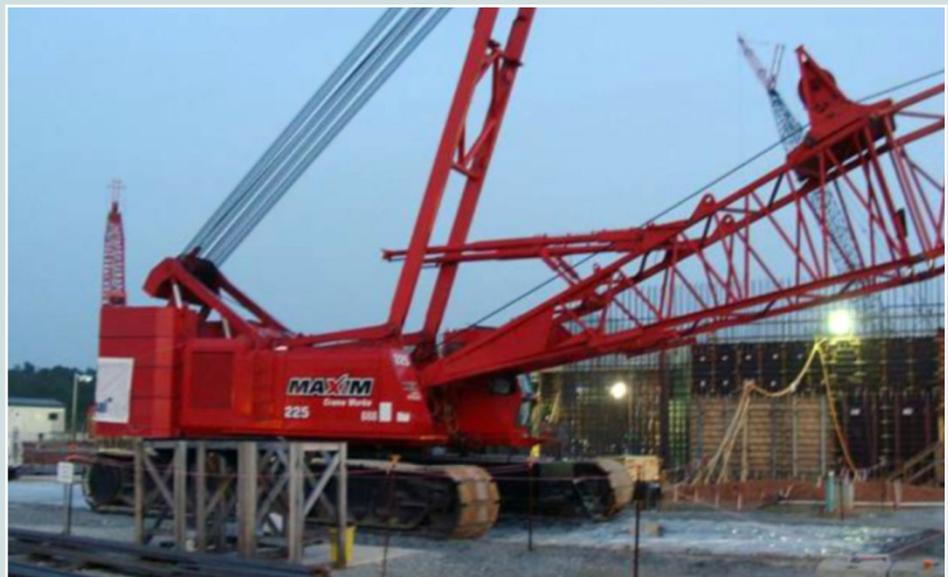
Type B Accident Investigation

Hand Injury at the
Salt Waste Processing Facility

October 6, 2009

Hand Injury at the Salt Waste Processing Facility, October 6, 2009, Savannah River Site ([ORPS Event EM-SR--PSC-SWPF-2009-0010](#)) — An Apprentice Crane Operator received a serious injury to the left hand and fingers while performing lubrication of the wire rope on a mobile crane. The Apprentice had his hand caught between the wire rope and the sheave over which the rope passes, resulting in a crushing injury to the left hand and fingers.

Construction site supervision was aware that the lubrication evolution was to be conducted, but the evolution was not identified in the listing of work activities for the shift. A task-specific Job Hazards Analysis had not been performed to develop formal controls for the evolution. The job was discussed in the Safe Work Briefing for the shift, but the specific lubrication method being used at the time of the accident was not discussed. The lubrication method being used at the time of the accident was not in accordance with methods specified in the mobile crane's operating manual.

The Board determined the Direct Cause as "The Apprentice Crane operator's left hand was caught between the wire rope and the crane sheave."

The Board determined the Root Cause as "An unsafe method was used to apply lubricant to the wire rope."
