OE-3: 2017-04

Electrofusion Coupling Failures

This Operating Experience Level 3 (OE-3) document provides information about recent electrofusion coupling failures and the importance of proper installation.

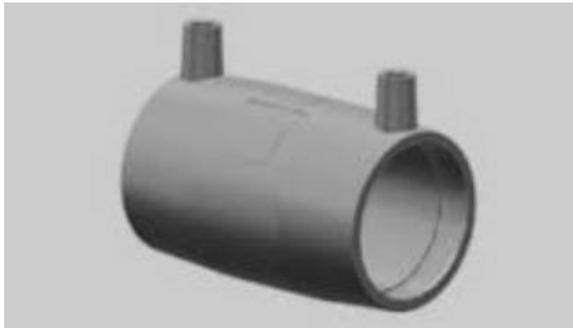
Electrofusion Couplings (Figure 1) are designed to connect two ends of High Density Polyethylene (HDPE) piping together where an electrofusion butt weld cannot be performed.

Figure 1: Electrofusion Coupling

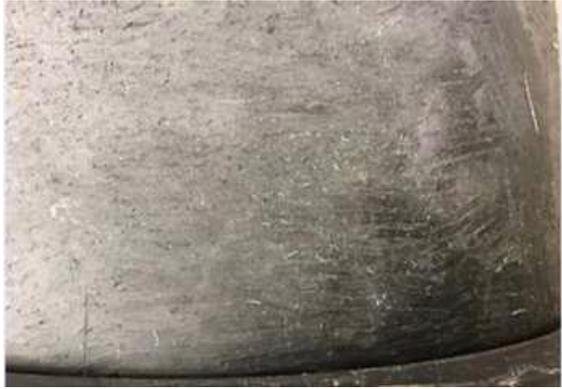
- There were no alignment/stab depth marks visible on the pipe, resulting in an improperly centered coupling.
- One side of the pipe surface was scraped with a rasp or similar tool, but material was not removed from the pipe (Figure 2). The other side had been scraped with a peeler, but less than 0.003" of material was removed. The manufacturer requires at least 0.007"-0.010" of outer pipe surface to be removed in the coupling area. This will assure virgin pipe material is exposed and remove any contaminants that will affect the fusion process.

Figure 2: Coupling #1 Pipe surface was scraped.

Ensure pipe ends are scored and marked to assure the depth of scraping as well as any flat spots are properly skinned to at least 0.007”.

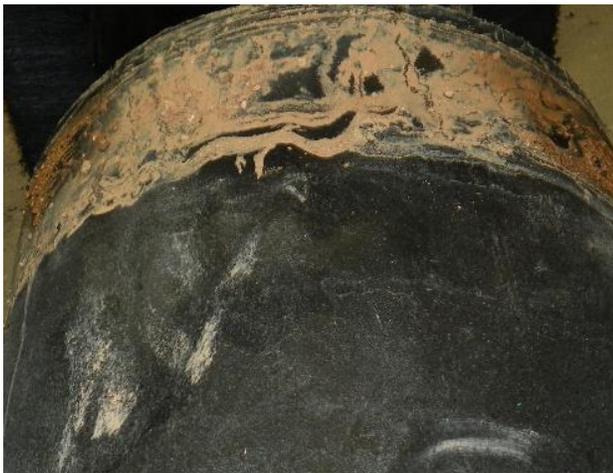
- When the coupling assembly was bisected for destructive testing, the pipe immediately separated from the coupling (Figure 3). ASTM F1055 requires the pipe to adhere to the coupling and not separate during a crush test.
- The pipe was damaged due to evidence of the fusion joint leaking for an extend period of time.

Figure 3: Dirt and mud in an area of the pipe and coupling where fusion between the HDPE should have occurred.

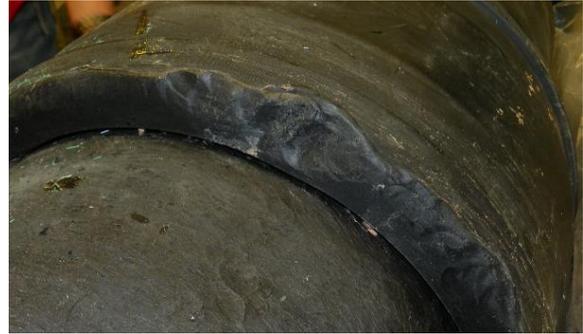
- Indication the joint was fused in a bind [e.g., hammer blows on the coupling (Figure 4) and joint was not straight (Figure 5)].

Figure 4: Hammer blows to the coupling indicate that pipe ends were not aligned and force was needed to install.

Ensure the pipe is restrained during and after the fusion cycle. This will restrict movement during the process and alleviate or eliminate sources of stress and strain until both the fusion and the cooling cycle are completed.

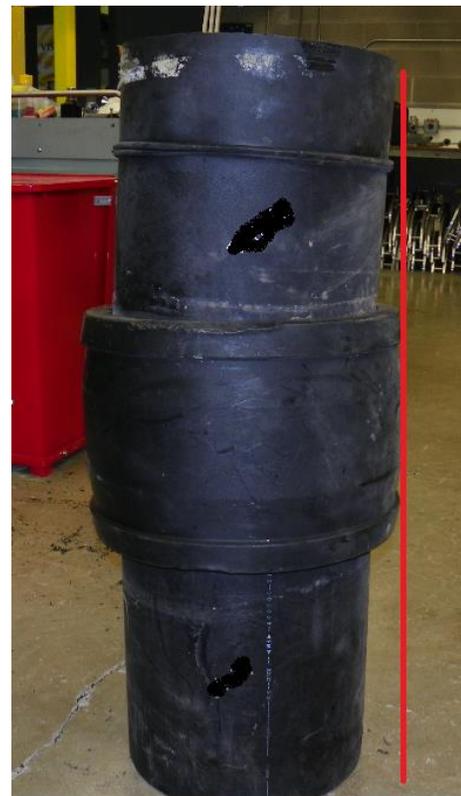
Figure 5: The pipe end and couplings were not properly aligned.

Ensure pipe ends are cut square/straight.

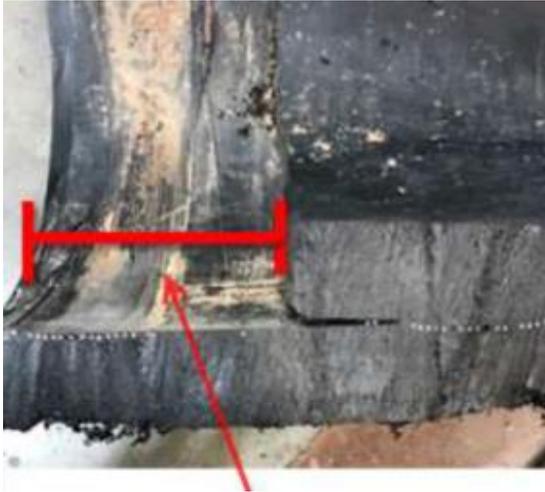
- There were no alignment/stab depth marks visible on the pipe causing the pipe to be severely miss-stabbed (Figure 6). This allowed the pipe end to be centered in the fusion zone which negated the performance of the cold zone during the fusion process.

Figure 6: Pipe section is severely miss-stabbed.

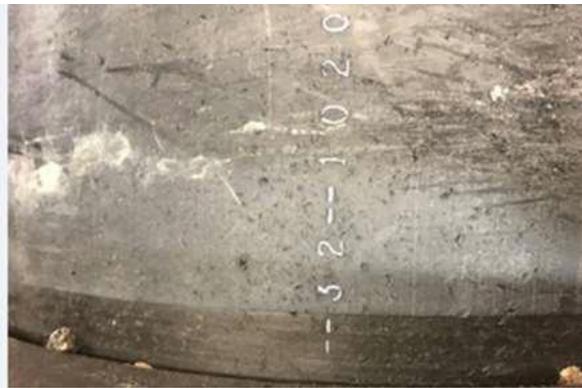
- One side of the pipe surface was scraped with a rasp or similar tool, but material was not removed from the pipe. The other side had been scraped with a peeler, but less than 0.002" of material (Figure 7).

Figure 7: Scraping and the evidence of the print line which is only printed on the outer surface of the HDPE.

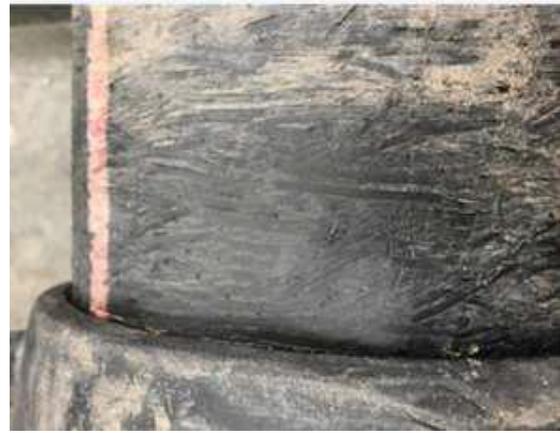
- One end of the pipe was scraped using a rasp or similar tool with multiple un-scraped sections of pipe. There was no evidence of scraping at all on the other end of the pipe. (Figure 8)

Figure 8: Scraping of pipe surface with a rasp.

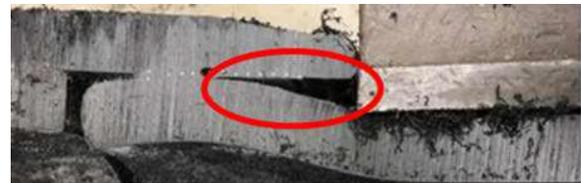
- The pipe on side two was placed in a vice to perform a crush test. The pipe on side two separated beyond the 15% allowance when the pipe walls were compressed approximately 40% (Figure 9).
- Indication that the joint was fused in a bind.

Figure 9: Results of crush test.
