OE-3: 2018-03

## Engineered Sling Protection

### PURPOSE

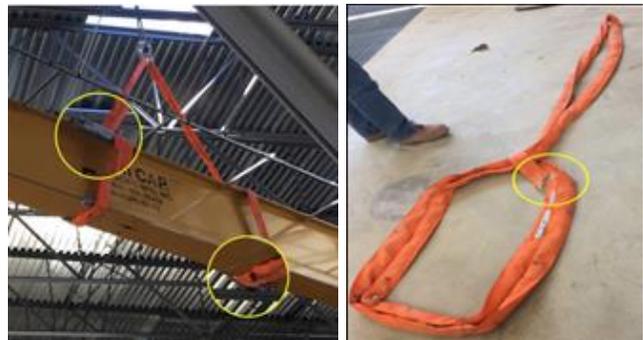
On July 15, 2017, at the Stanford Linear Accelerator Center, a bridge crane girder dropped 15 feet during a lift by a mobile crane. Slings slipped off softeners during the lift because dynamic forces applied during the lift increased the horizontal force on the slings, which overcame the force of friction on the softener. The slings failed when they contacted the edge of the load. (See photos below.) There were no injuries. The girder and the concrete floor were damaged when the load dropped. (ORPS Report SC--SSO-SU-SLAC-2017-0003)

*Photos showing sling failure that caused girder to drop*

Low sling angles apply a larger force due to the load angle factor within the sling itself. A low sling angle also applies a large horizontal force that must be addressed. The preferred sling angle for a choked or basket hitch is greater than 75° from the horizontal (15° from the vertical) to prevent sliding. The minimum allowed is 60° from the horizontal, unless there are positive stops to prevent sliding; otherwise a spreader bar should be used to distribute the load of the lift across more than one point, increasing stability and decreasing the loads applied during hoisting.

Full evaluation of the loads and their interaction with the lifting surfaces should be performed to ensure that there are no sharp edges that could damage the lifting equipment. Sling protection must be evaluated and used to prevent damage to the lifting equipment and eliminate potential for a dropped load.
