# Hanford Lessons Learned/Operating Experience Information Bulletin

2009-RL-HNF-0040

## Man Lift Fatalities at Waltham Construction Site

**Date Published:** December 1, 2009

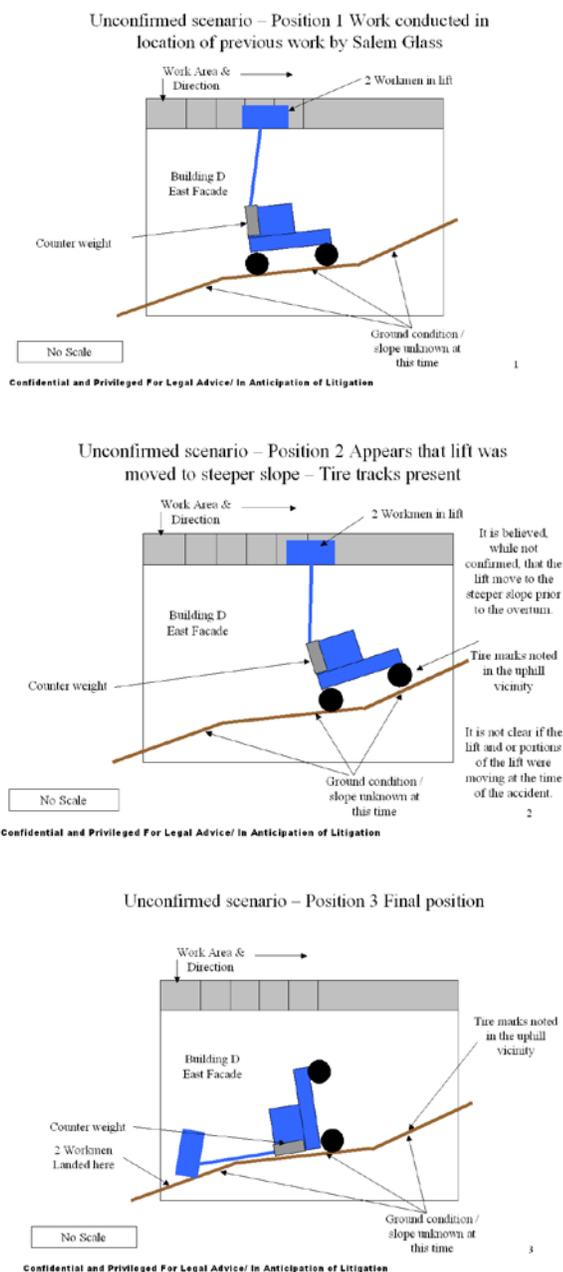
- ◆ **The work area where the boom was operating was not level** – Lifts/booms should only operate on a suitable, firm, level surface.
- ◆ **Counter weight and extension boom positioned improperly** – The contractors began to reposition the boom uphill while standing on the platform with the arm extended, on an uneven slope. The counter weight was located on the downhill side, shifting the center of gravity to the downhill side, causing it to flip backwards.

- ◆ **Failure of tilt sensor and audible alarm** – The tilt sensor is specifically designed to alert the operator(s) in the lift basket, via audible alarm, when an unsafe condition (non-level working orientation) is being approached. The resulting OSHA investigation discovered that the Tilt Alarm been disconnected, although when and by whom was never fully understood.

- Only operate on suitable, firm and level surfaces
- Never operate drive system while boom in extended position
- Ensure Pre-Task planning accounts for all operating conditions and parameters related to the specific equipment being used
  - Includes review of equipment operations manual
  - Provides for pre-operation inspections, including safety systems integrity (e.g. tilt alarm is in proper working condition)
  - Incorporates review of specific site and area conditions
  - Ensures next, immediate user of borrowed equipment is responsible for its readiness for use
- Consider physical barriers to prevent boom lift movement in areas where unlevelled or unstable conditions are adjacent to planned work area
- Training should be specific to the type and model of equipment being utilized
- Robust maintenance and inventory program to ensure equipment is in appropriate working condition.
