Level I Accident Investigation
Report
March 1, 2010
Fatal Bobcat/Backhoe Accident
At the White Bluffs Substation

**Report Date:
March 31, 2010**

BPA
Level I Bobcat/Backhoe Accident, March 1, 2010 at White Bluffs Substation
Final Report

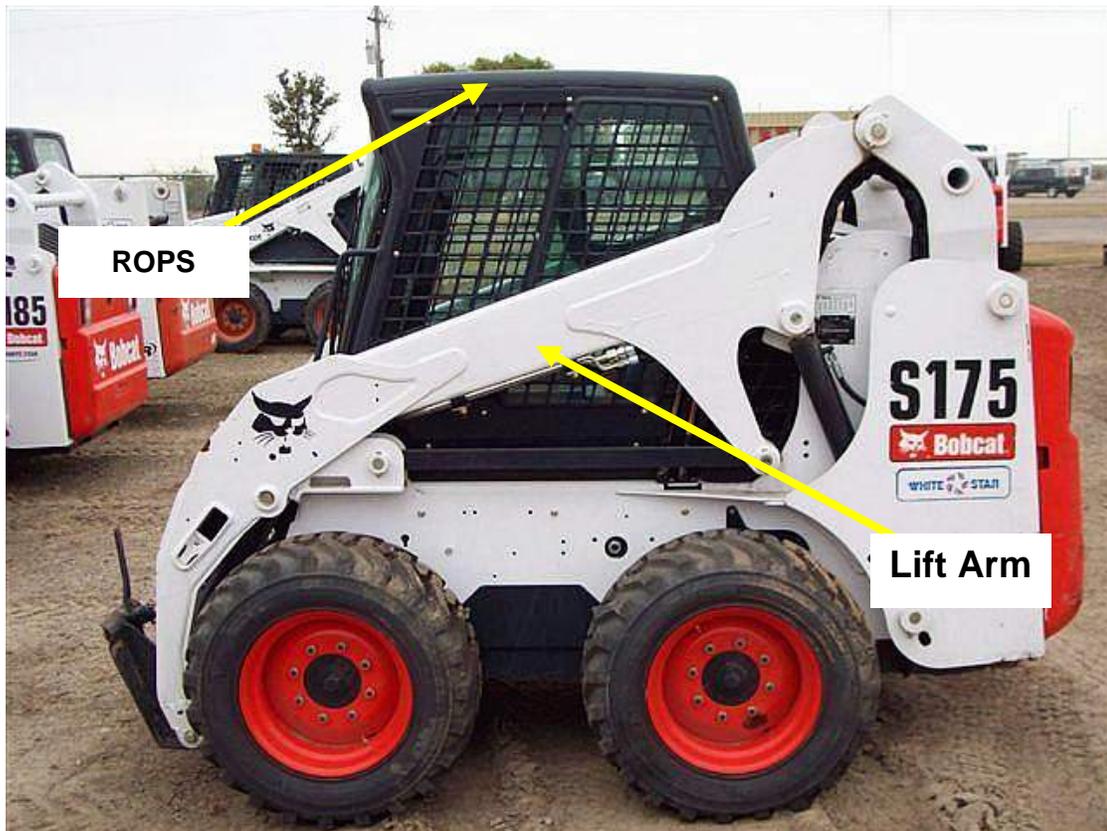
Figure 2-1: Bobcat S175

The Bobcat S175 Skid-steer loader is a small rigid-frame, rubber-tired machine weighing 6,220 lbs, and 68'' wide. It is a diesel-powered machine with lift arms used to attach a wide variety of tools or attachments. The Bobcat, a four-wheel drive machine, has the left-side drive wheels independent of the right-side drive wheels. By having the drive wheels independent of each other, wheel speed and rotational direction of the wheels determine the direction of the loader. Forward, reverse, travel speed and steering are controlled by two hand levers. Two foot pedals control the hydraulics that raise and lower the lift arms and the dump and rollback of the bucket. Bobcats are capable of zero-radius, "pirouette" turning, which makes them extremely maneuverable and valuable for applications that require a compact, agile loader. The lift arms on these machines are alongside the driver seat outside the cab with the pivot points behind the driver. Bobcats have fully-enclosed cabs and other features to protect the operator.

The Bobcat S175 is equipped with a safety interlock system, the Bobcat Interlock Control System (BICS™). To activate the hydraulic lift/tilt functions, the BICS™ requires the seat bar to be in the lowered position, the engine running, and the “press to operate loader” button pushed. See Appendix D: Bobcat Interlock Control System.

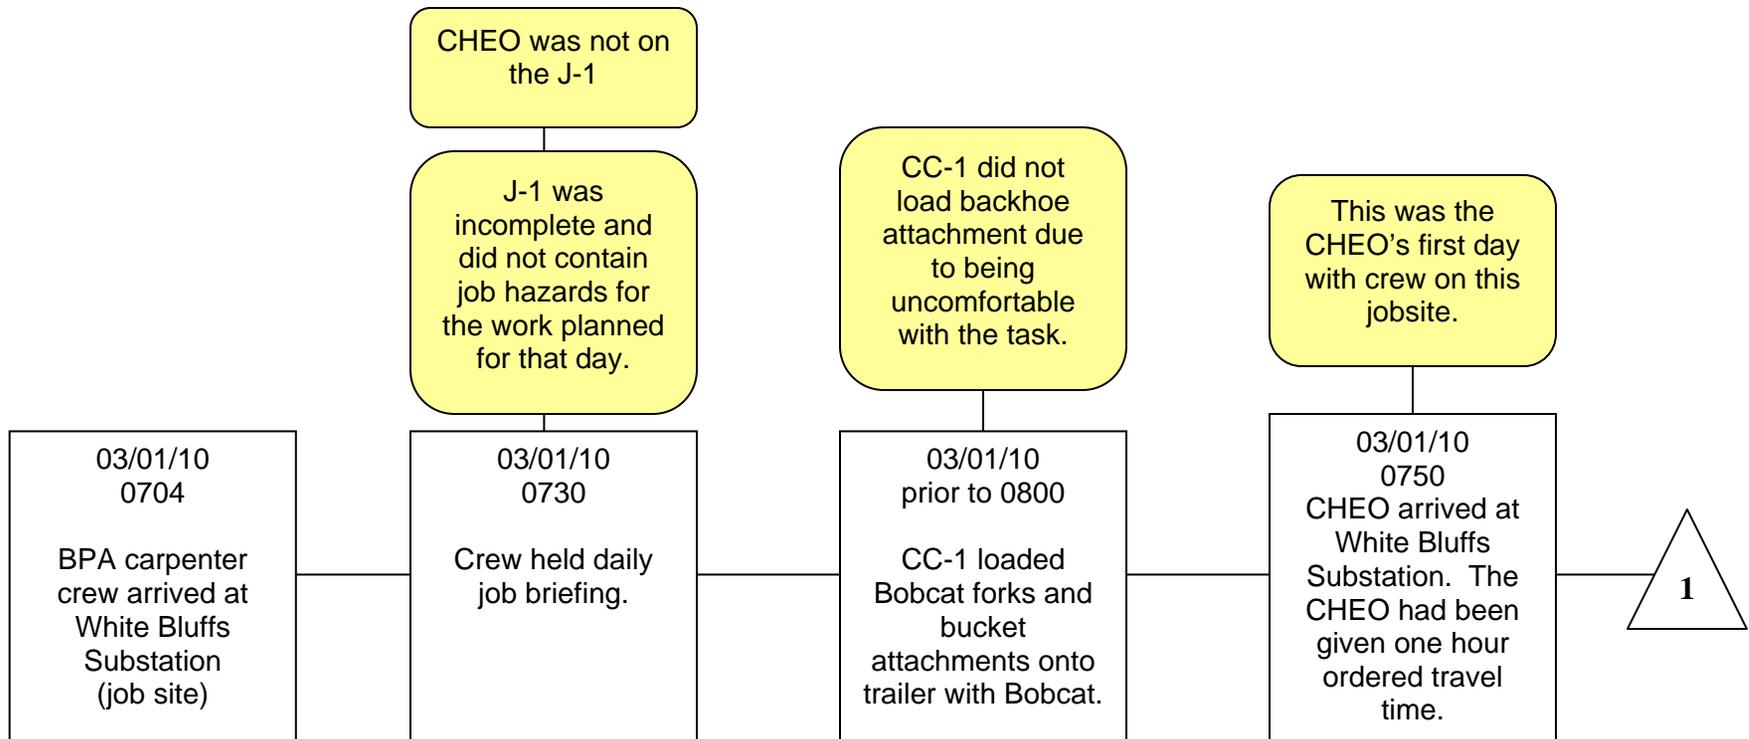
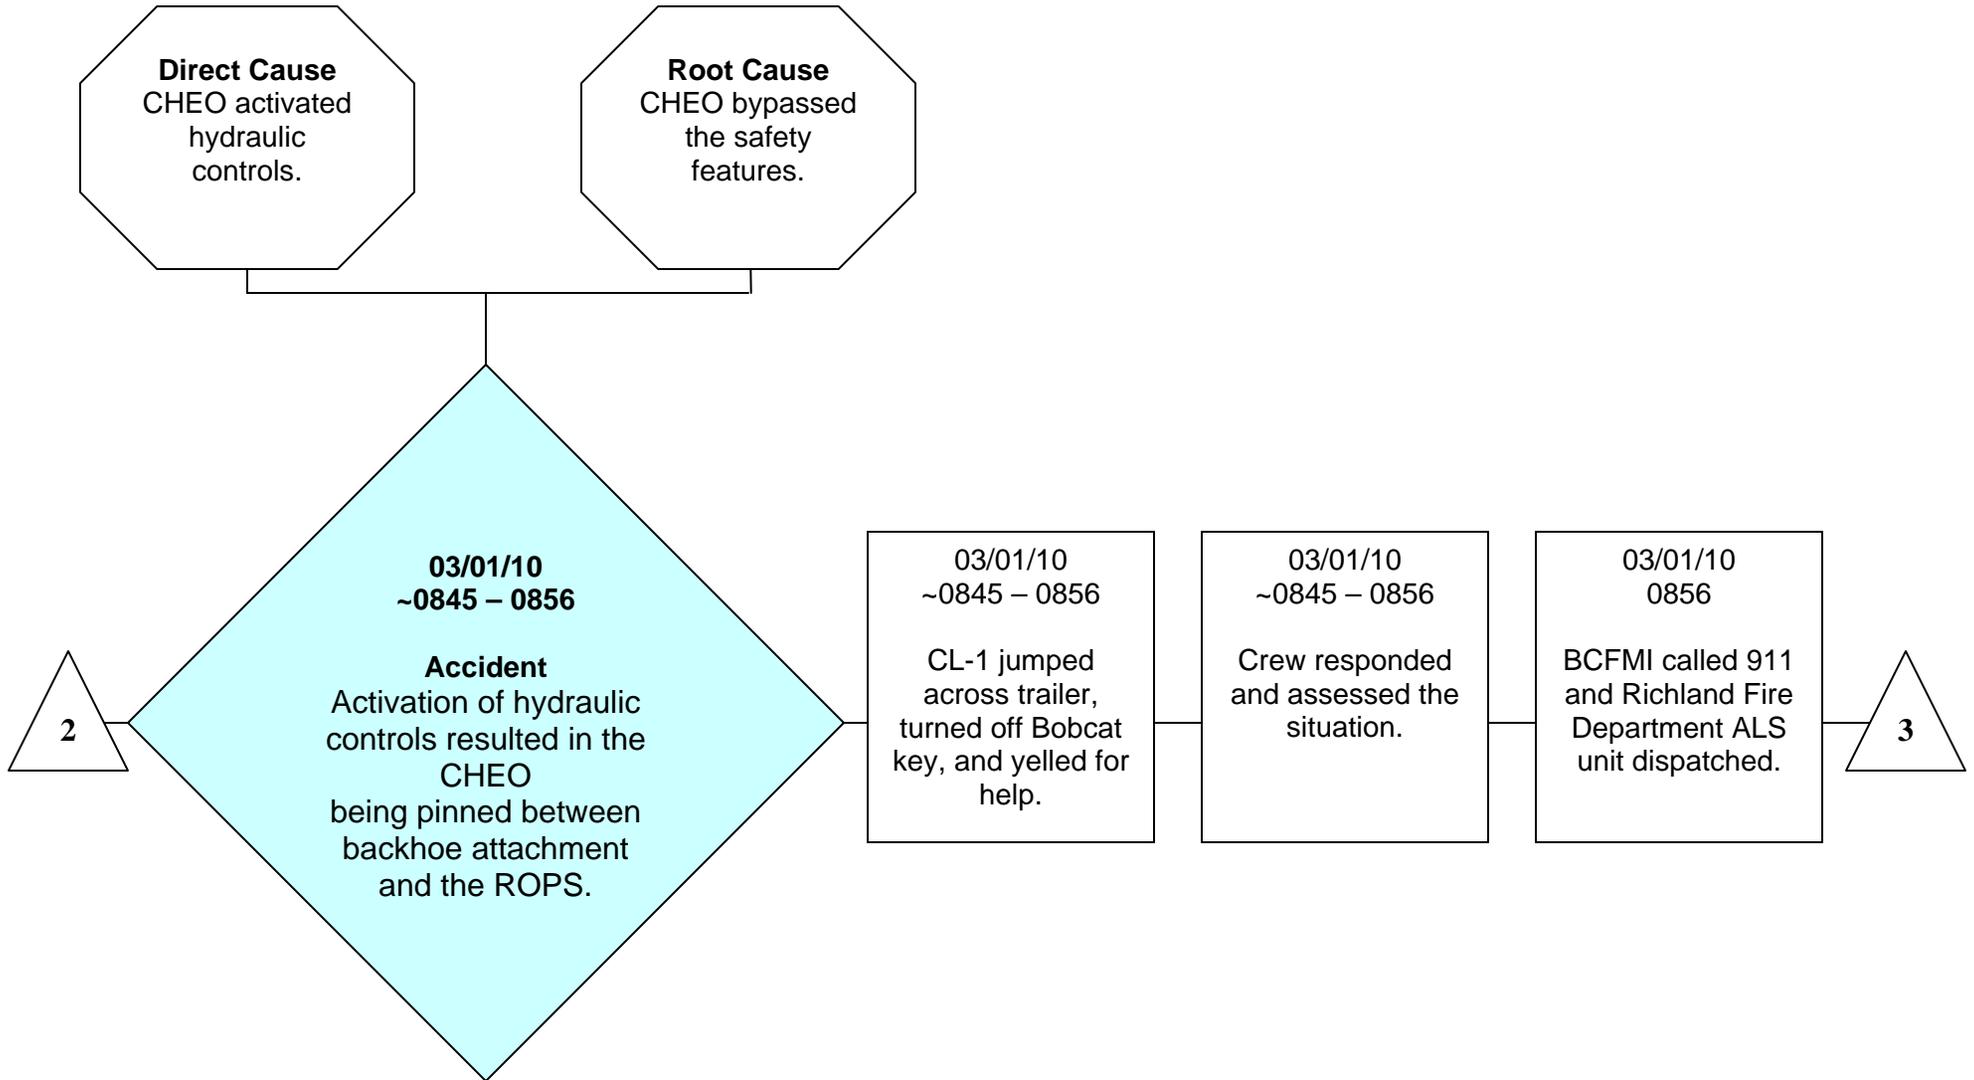
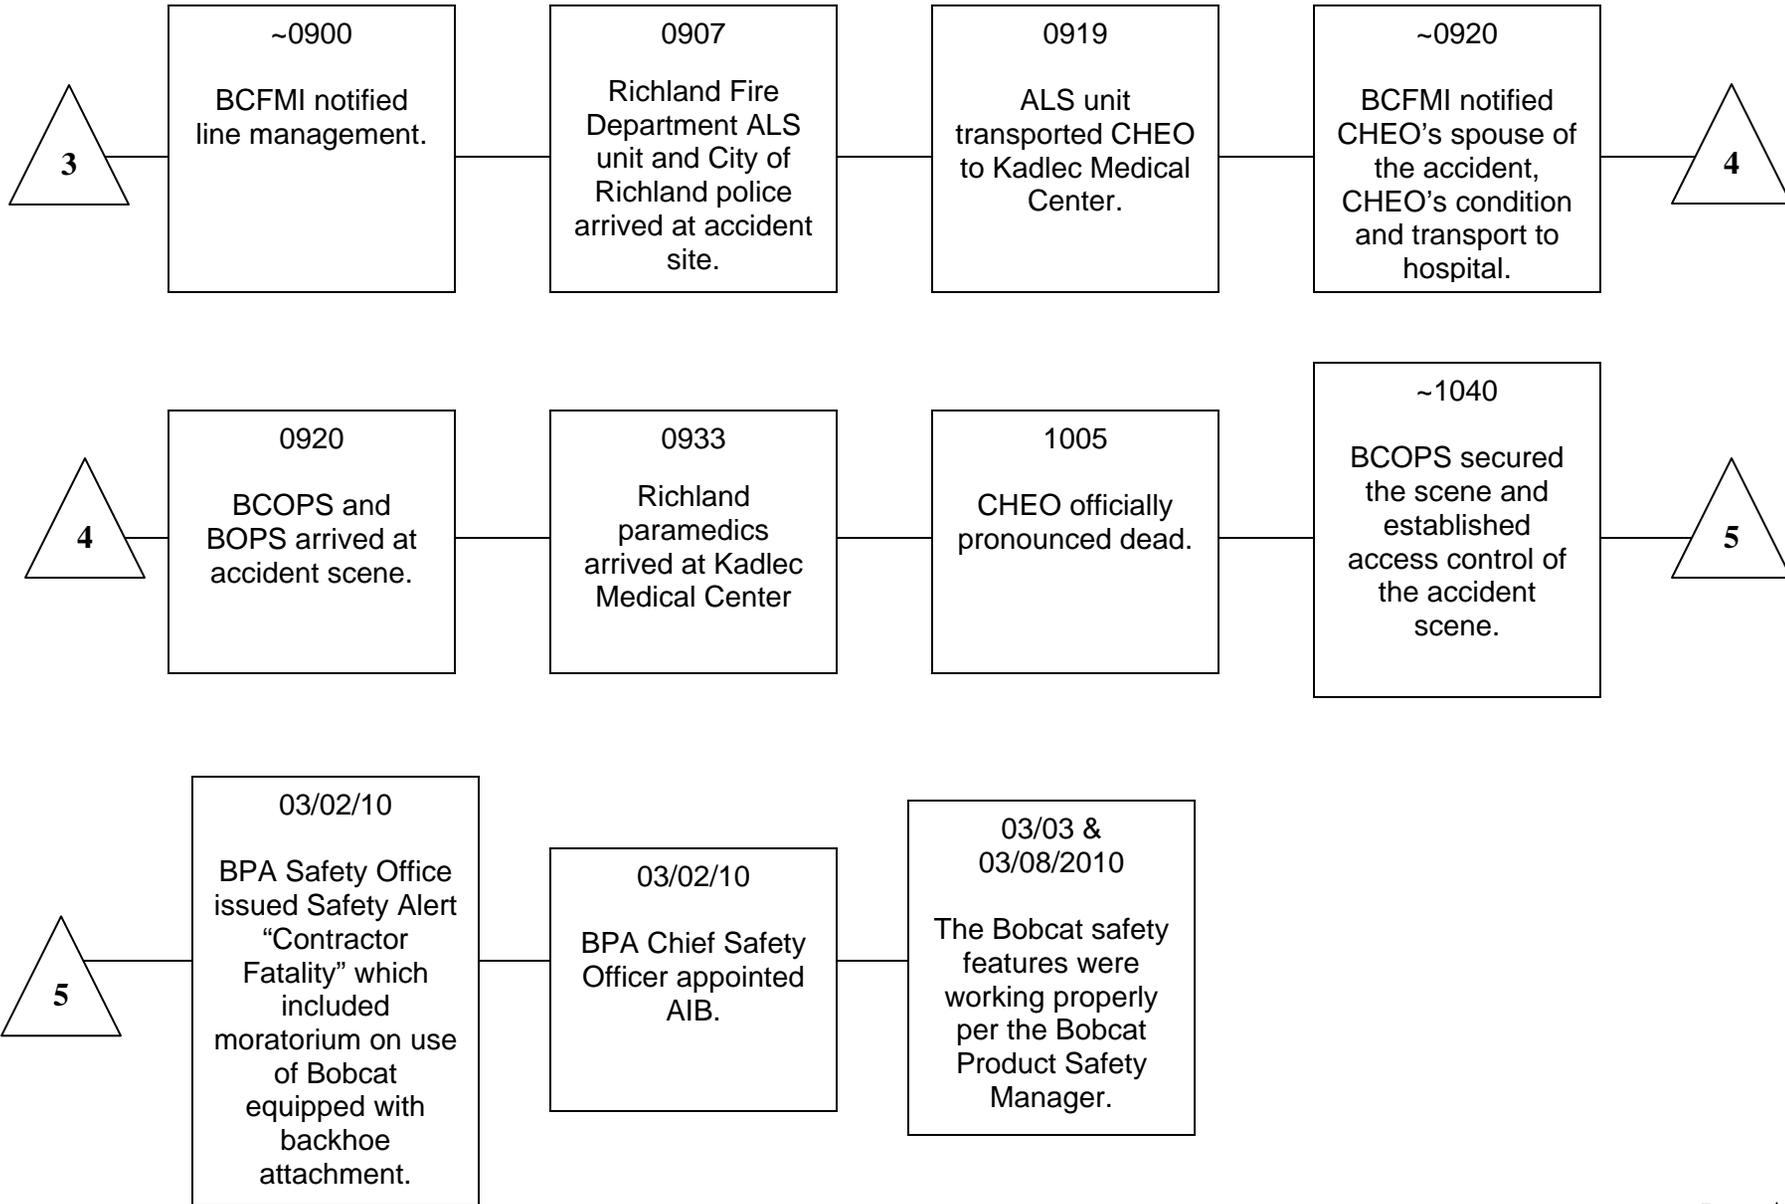
A direct cause is the immediate event or condition that caused the accident. The AIB concluded that the direct cause of this accident was that the CHEO activated the hydraulic controls while standing in the pinch point. The Board determined the root cause of the accident was that the CHEO bypassed the Bobcat safety features. The AIB also identified contributing causes which are events or conditions that collectively with the other causes,

increase the likelihood of the accident, but individually did not cause the accident. The AIB concluded that a contributing cause of this accident was that the CHEO did not receive a sufficient J-1 (pre-job briefing that included work planning, job hazards analysis, and controls). An interview with the BCFMI and a review of the written J-1 the day of the accident indicate that the briefing the CHEO received, an hour after the crew's job briefing, was verbal and only included assignment of job tasks associated with moving tools and equipment to a new job site.

The AIB determined that a second contributing cause was that the J-1 briefing for the entire crew was insufficient on the day of the accident. A review of the written J-1 from the day of the accident indicated that the work to be performed at the work site was unchanged from previous days' J-1's which included setting forms and pouring concrete and in fact did not reflect the actual work that was planned for that day (loading materials, tools, equipment to mobilize to next job site).

An events and causal factors analysis was performed in accordance with the DOE workbook *Conducting Accident Investigations*. The events and causal factors analysis requires deductive reasoning to determine those events and/or conditions that contributed to the accident. Causal factors are the events or conditions that produced or contributed to the accident, and they consist of direct, contributing, and root causes. The direct cause is the immediate event(s) or condition(s) that caused the accident. The contributing causes are the events or conditions that, collectively with the other causes, increased the likelihood of the accident, but which did not solely cause the accident. Root causes are the events or conditions that, if corrected, would prevent recurrence of this and similar accidents. The causal factors are identified in Figure A-1: Events and Causal Factors Analysis on pages A-1 through A-4.
