**Type A Accident
Investigation Board Report
on the February 13, 1997,
Welding/Cutting Fatality
at the
K-33 Building, K-25 Site
Oak Ridge, Tennessee**

**Type A Accident
Investigation Board Report
of the February 13, 1997
Welding/Cutting Fatality
at the
K-33 Building, K-25 Site
Oak Ridge, Tennessee**

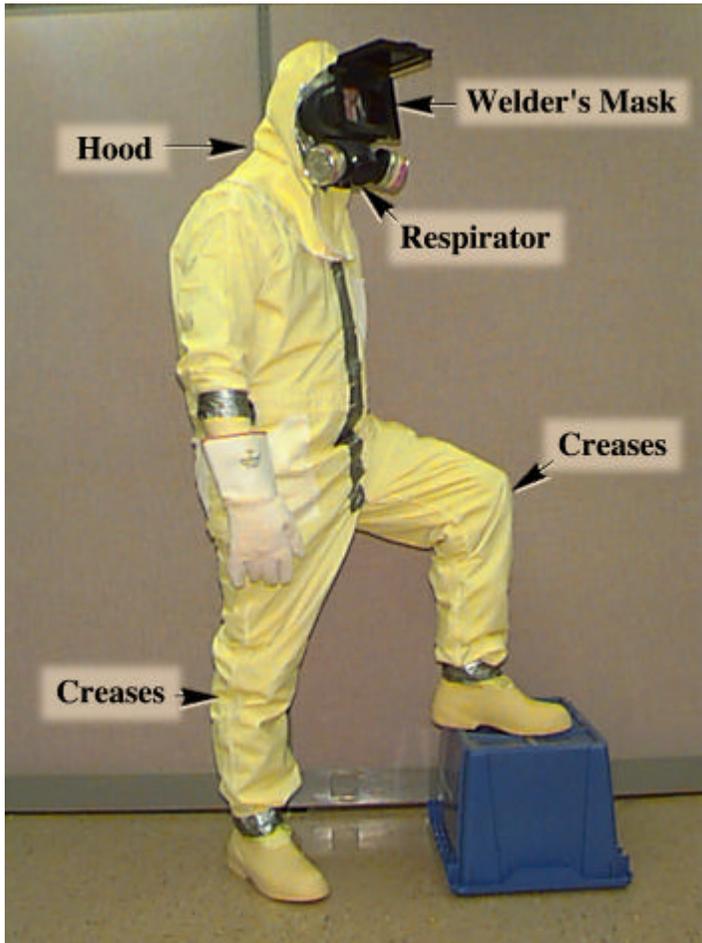
Exhibit 2-1. Similarly Outfitted Welder

At the time of the accident, the Welder was wearing one set of underwear, one set of 100 percent cotton blue general-purpose coveralls, two sets of 100 percent cotton yellow anti-contamination coveralls, one pair of cotton liner gloves, one pair

At the time of the accident, the Welder was wearing three sets of coveralls, three pairs of gloves, four covers over safety shoes, a skull cap and hood, a personal air monitor, and a full-face respirator with an attached welding
