OE-3: 2017-03

## **S/CI Alert: Ratchet Strap Bolts**

### **PURPOSE**

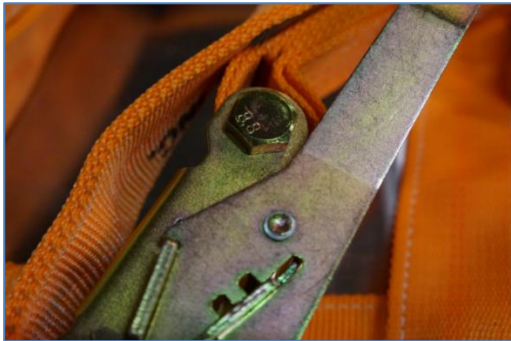
- 2) On December 1, 2016, a Quality Assurance (QA) inspector at the Portsmouth Gaseous Diffusion Plant inspected seven ratchet tie-down assemblies. The Purchase Order had requested 10,000-pound ratchet straps that met all Department of Energy (DOE), California Highway Patrol, and Commercial Vehicle Safety Alliance regulations, with a working load of 3,300 pounds and breaking strength of 10,000 pounds. The bolts connecting the ratchet to the webbing were observed to be potential suspect counterfeit (S/CI) with no identifiable head markings. The ratchet straps had been purchased from an established local vendor who purchased them from another supplier. The ratchet straps listed "Made for PALMETTO Equipment," the part number "5014 WH/WH 2P," and were labeled "Made in the USA." An internet search revealed no additional information on PALMETTO Equipment or the associated part number. QA personnel proceeded to follow up with the local vendor and were told that "D.O.T. Tie Down" was the manufacturer of the ratchet straps for PALMETTO Equipment. D.O.T. Tie Down

was contacted and written associated testing data was requested. A testing report was provided, but the provided written report was in a foreign language and could not be reasonably authenticated. In addition, this report did not appear to be an official associated document or linked to any of the listed manufacturers or the listed part number. (Lessons Learned Report B-2017-PMA-PORTS-001; ORPS Report EM-PPPO--PMA-PORTENVRES-2017-0001)

Figure 1. Image of S/CI bolt from Lessons Learned Report B-2017-PMA-PORTS-001

It is important to perform a thorough inspection of ratchet straps and other tie-downs upon initial arrival at DOE, and prior to each use. S/CI associated with straps and tie-downs can reduce load capacity and increase the risk of failure, thus presenting a serious risk of property loss, property

Tie-downs with any of these signs of defect or damage should be reported, labeled, and discarded.
